Advances in Seismic Structural Health Monitoring

Rubén Boroschek, Ph. D

**Professor
University of Chile**

**May 7
IOMAC**

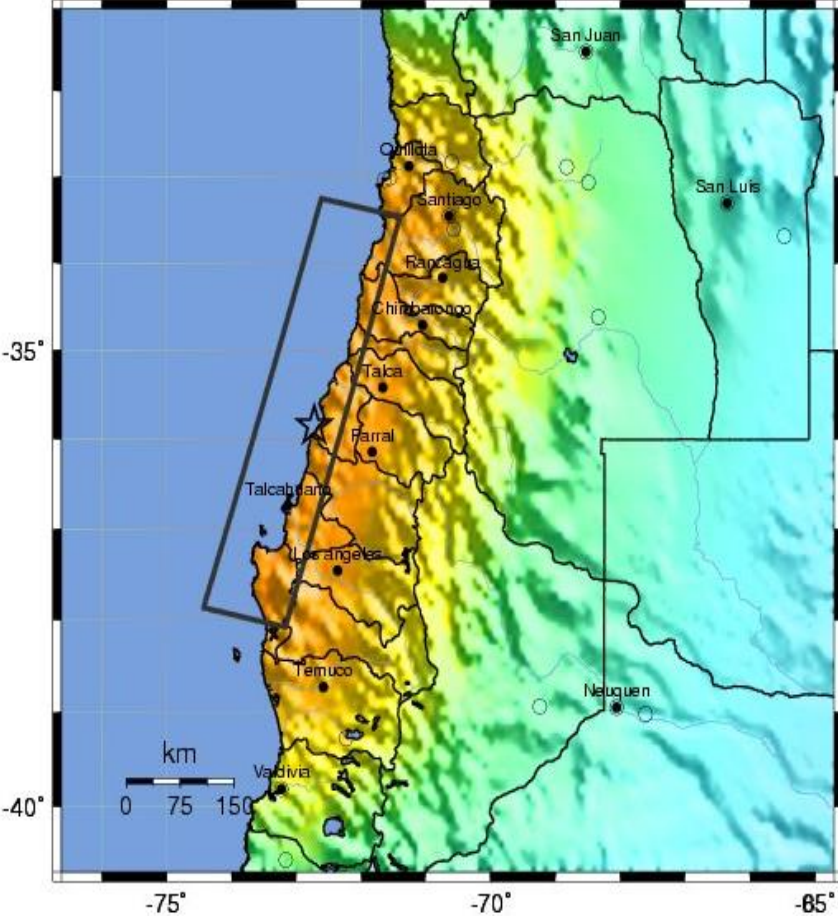
USGS ShakeMap : OFFSHORE MAULE, CHILE
 Sat Feb 27, 2010 06:34:14 GMT M.8.8 S35.85 W72.72 Depth: 35.0km ID:2010tfan

Map Version 6 Processed Sat Feb 27, 2010 01:40:36 PM MST - NOT REVIEWED BY HUMAN

PERCEIVED SHAKING	Not felt	Weak	Light	Moderate	Strong	Very strong	Severe	Violent	Extreme
POTENTIAL DAMAGE	none	none	none	Very light	Light	Moderate	Moderate/Heavy	Heavy	Very Heavy
PEAK ACC.(%g)	<.17	.17-1.4	1.4-3.9	3.9-9.2	9.2-18	18-34	34-65	65-124	>124
PEAK VEL.(cm/s)	<0.1	0.1-1.1	1.1-3.4	3.4-8.1	8.1-16	16-31	31-60	60-116	>116
INSTRUMENTAL INTENSITY	I	II-III	IV	V	VI	VII	VIII	IX	X+

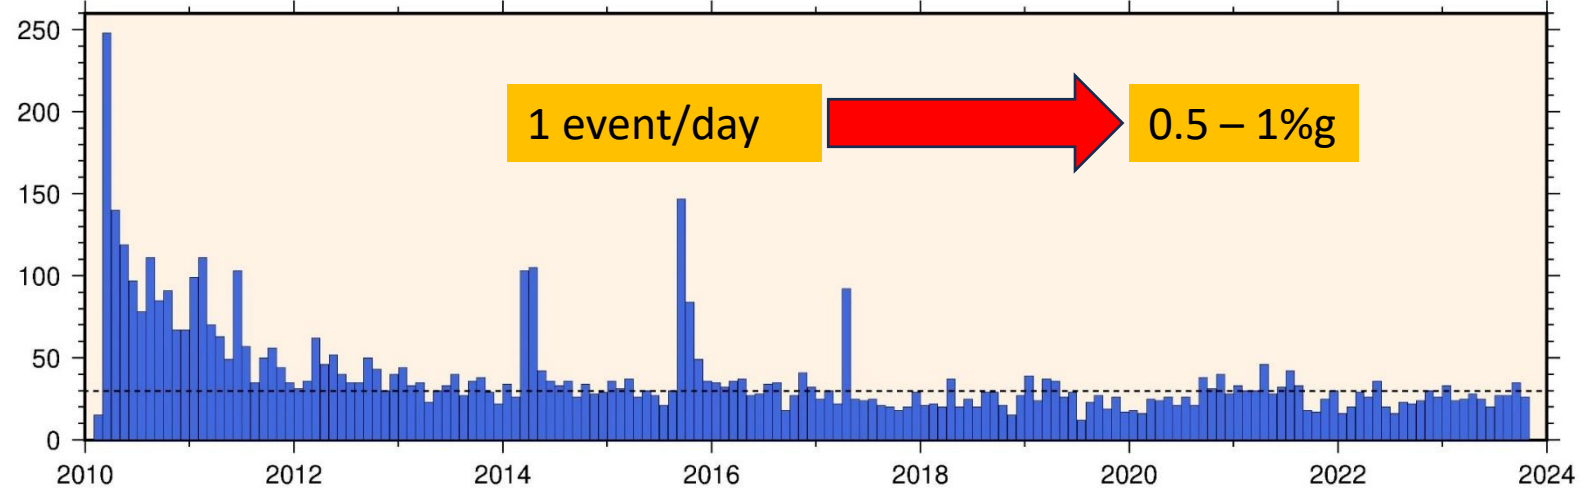
Number of felt earthquakes/month

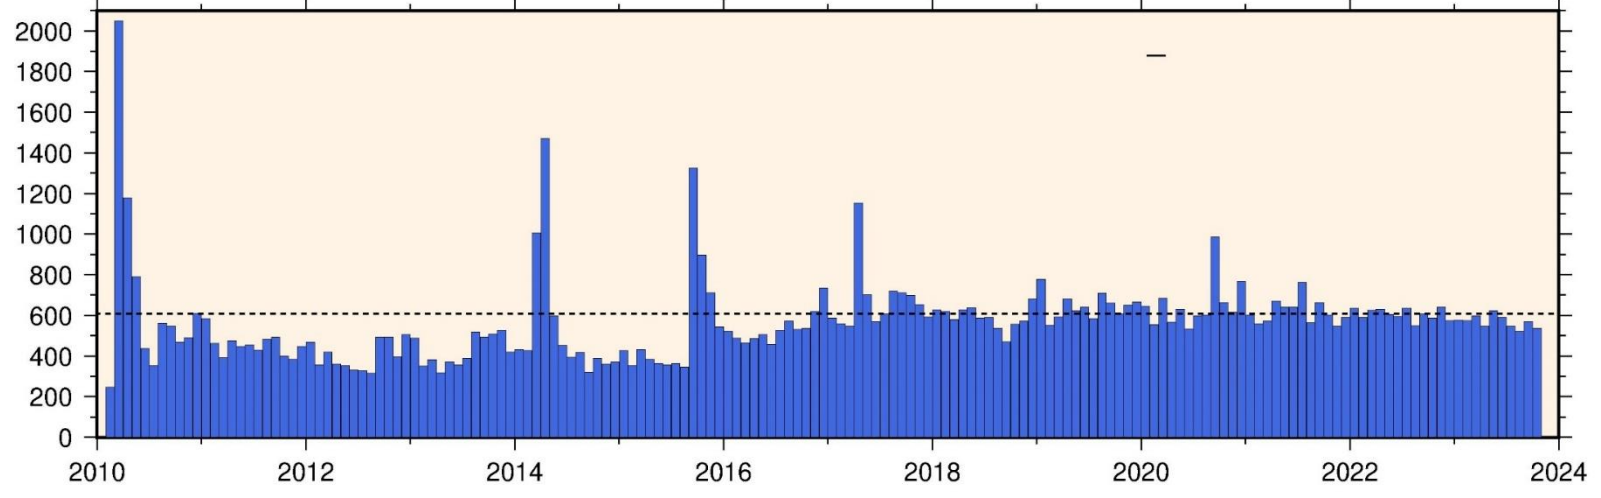
Total number of events/month (M > 3)

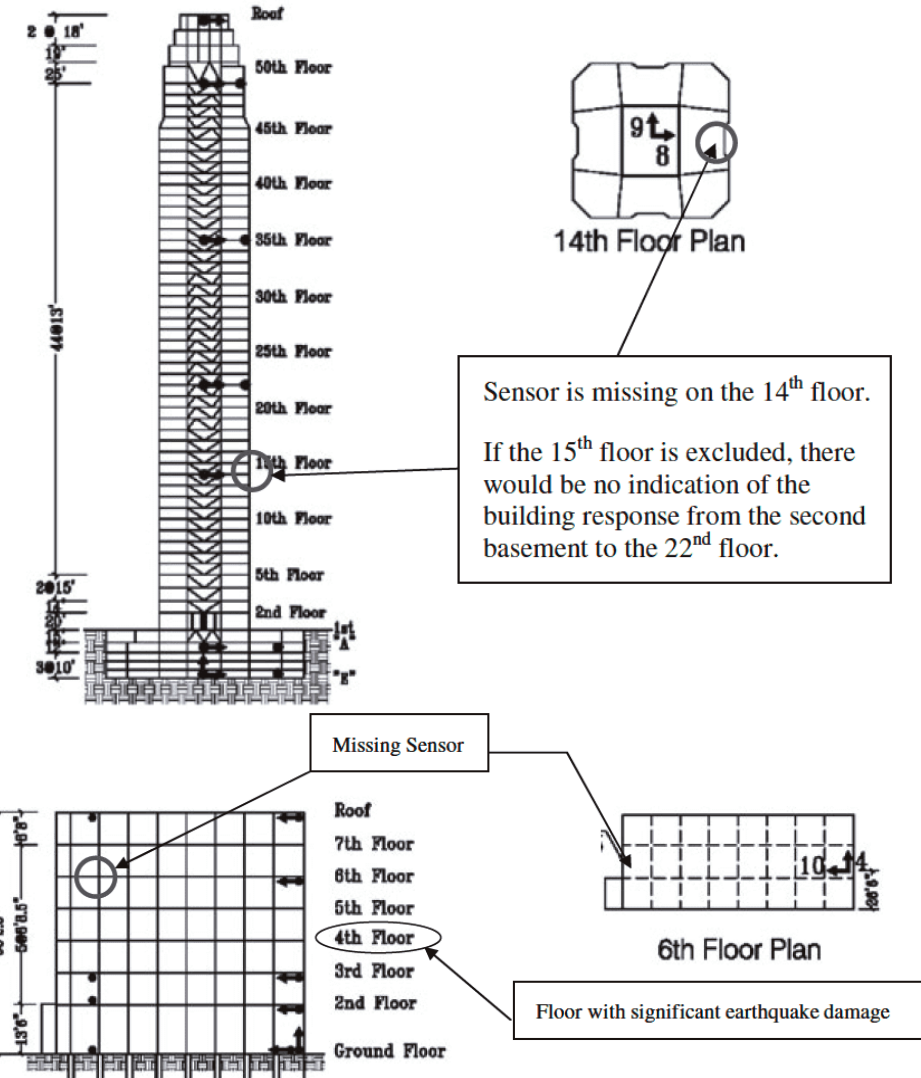
Common Sensor Distribution in Buildings and Objectives

I. Critical Parameters

- a. Interstory Drifts
- b. Base shear
- c. Residual drifts

II. Other Important Parameters

- a. Floor acceleration and spectra
- b. Maximum displacements

III. Damage detection

- a. Modal parameters
- b. Hysteresis
- c. CAV, Peak Structural Accel, Vel, Disp.
- d. Many others

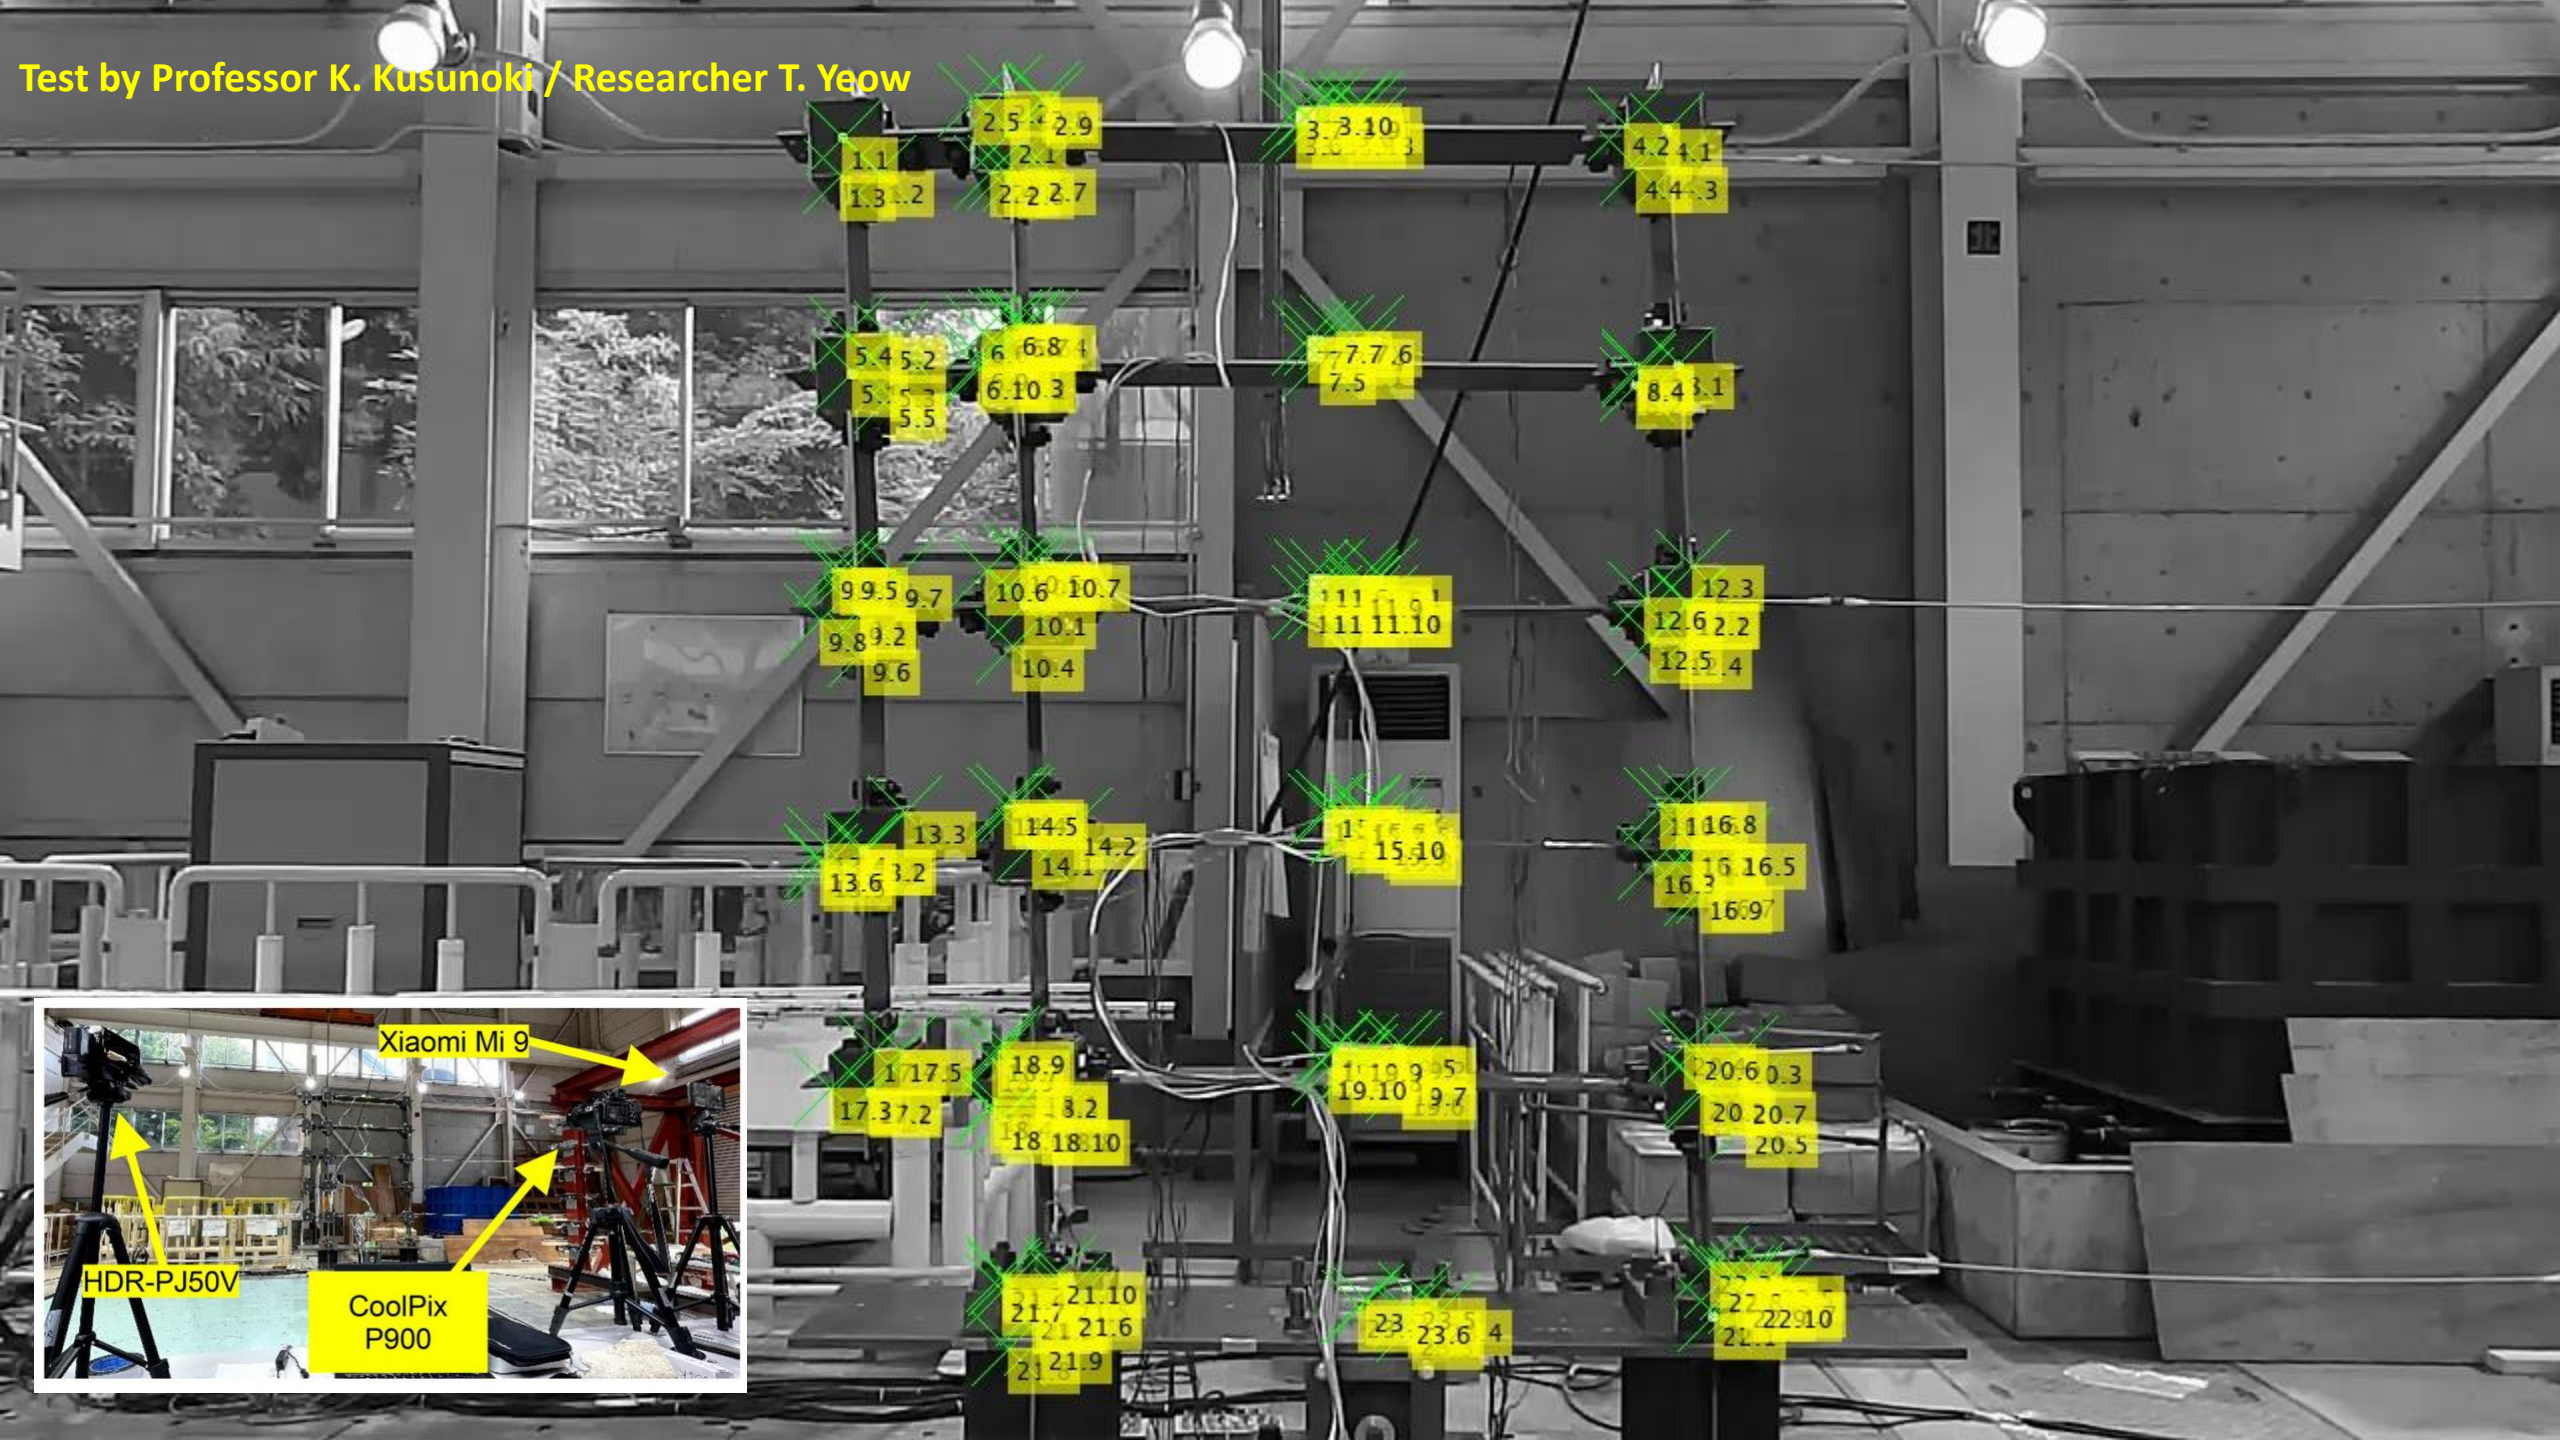
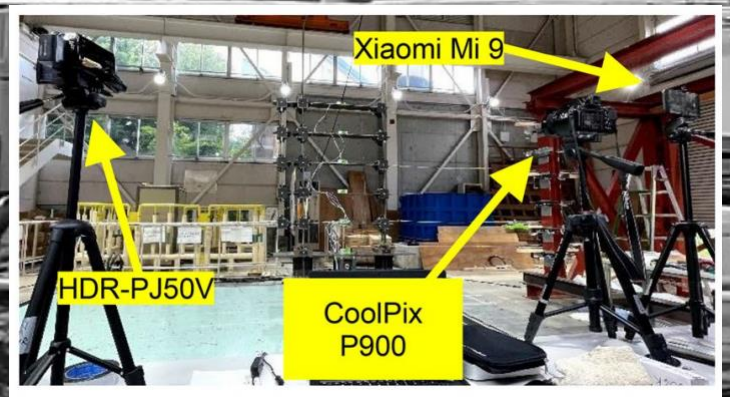
Test by Professor K. Kusunoki / Researcher T. Yeow

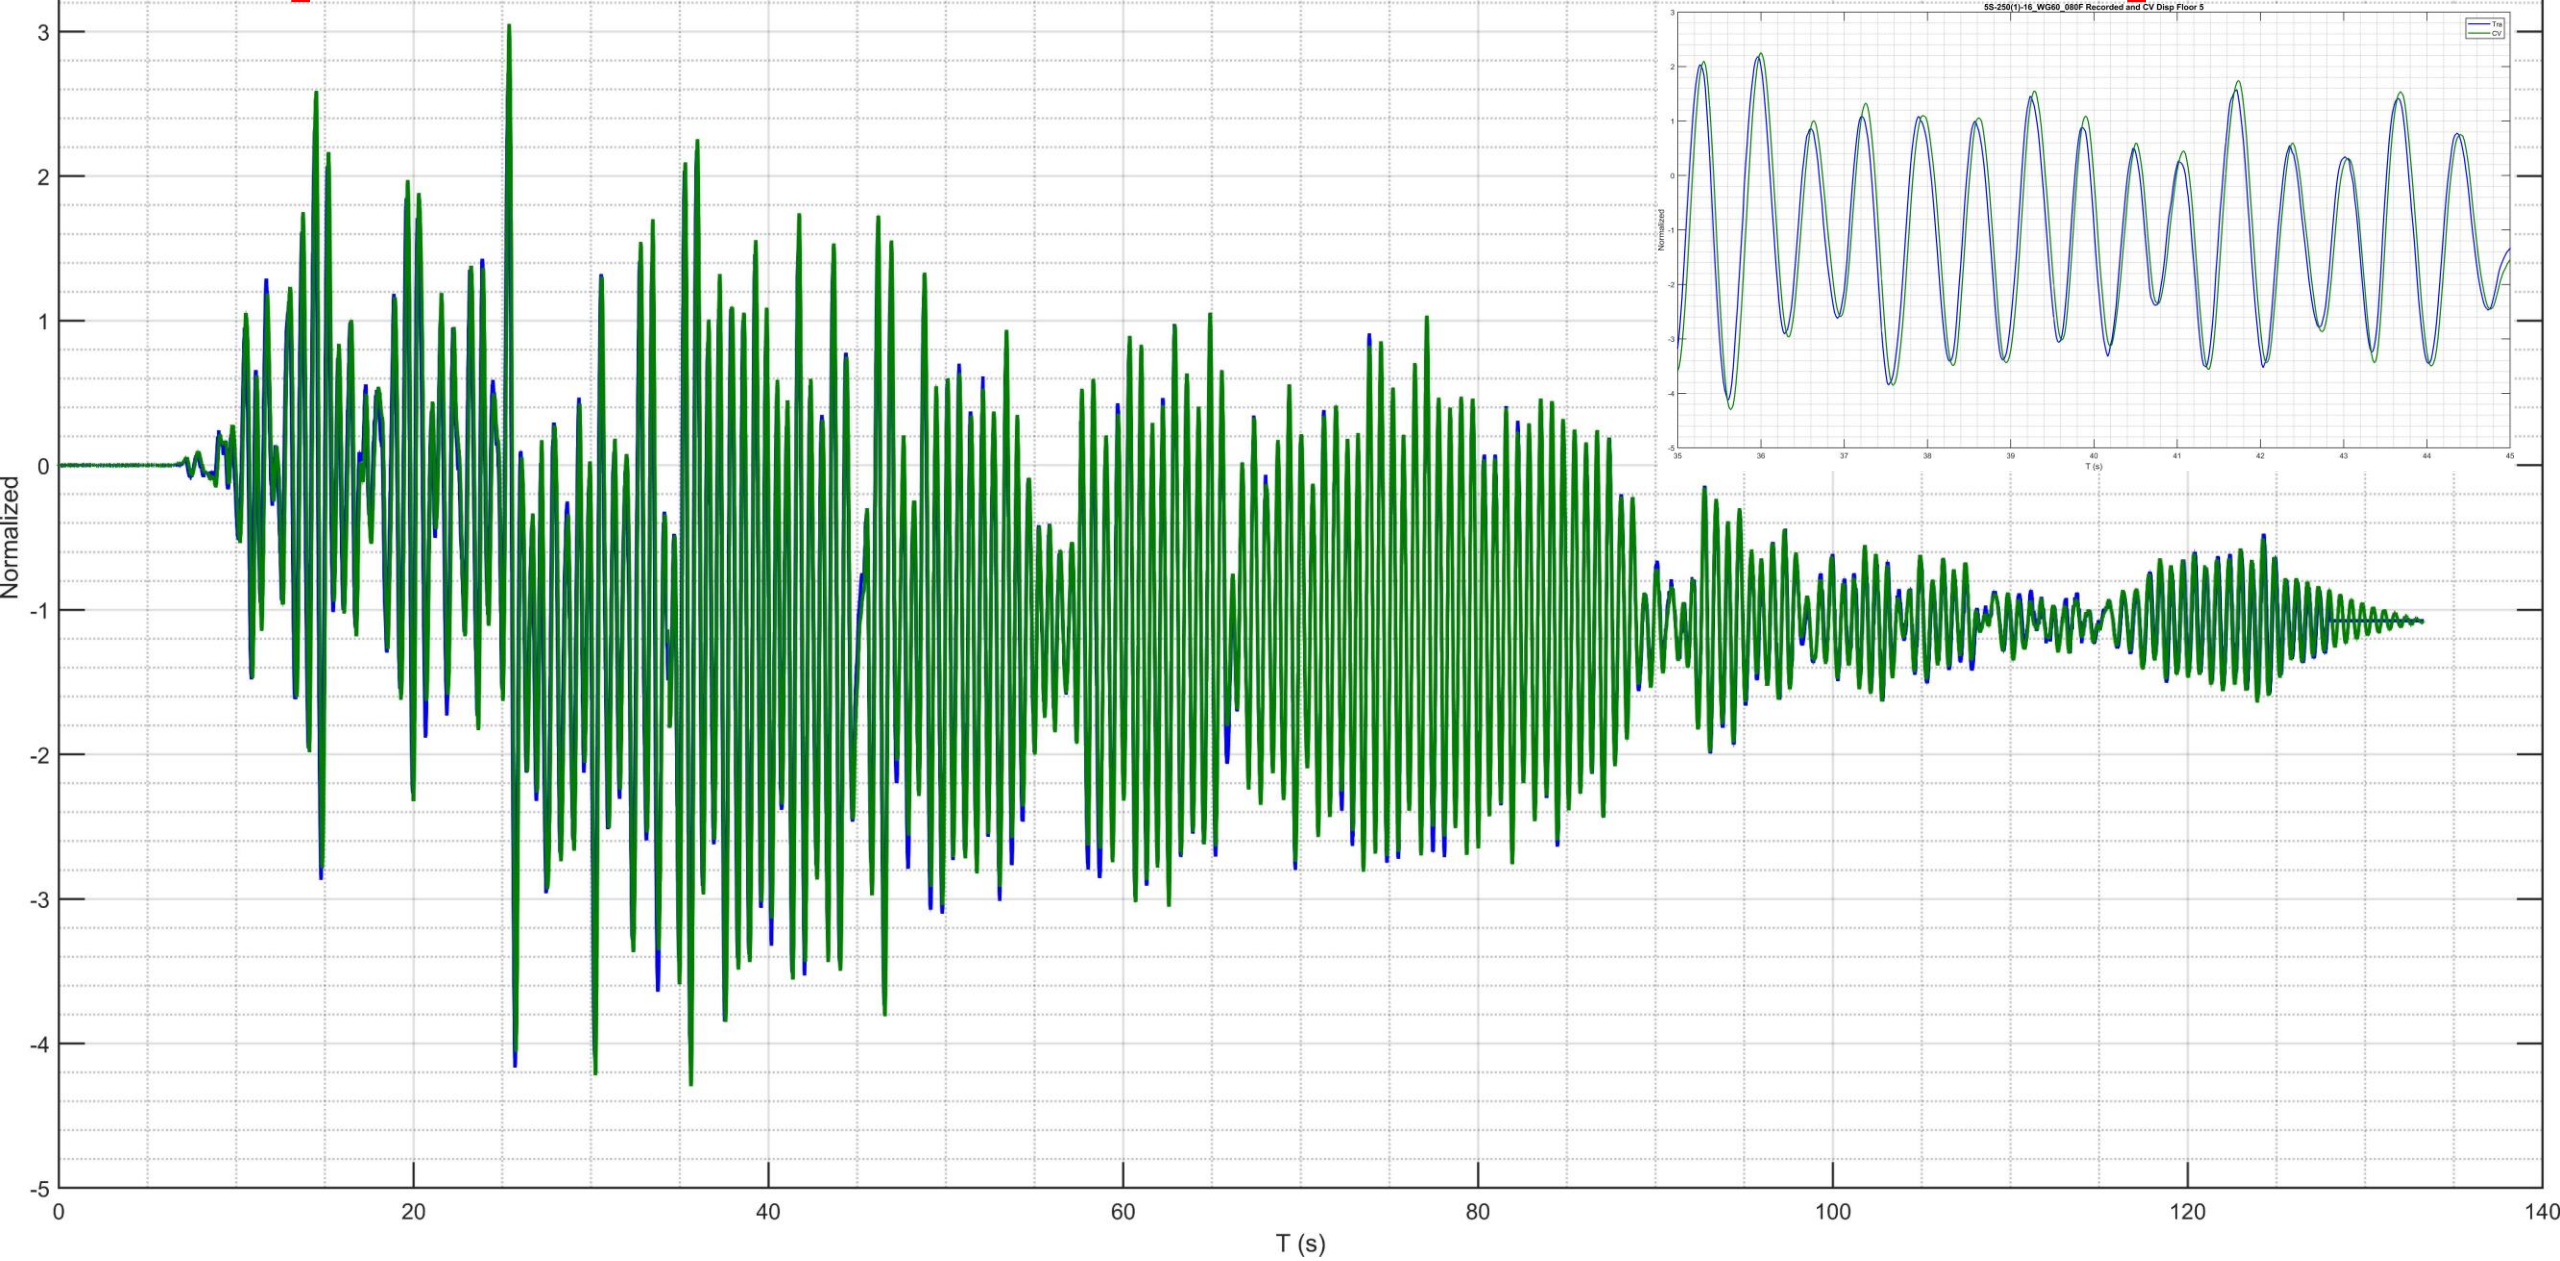
Comparison Transducer and CV Disp F 5

Tra
CV

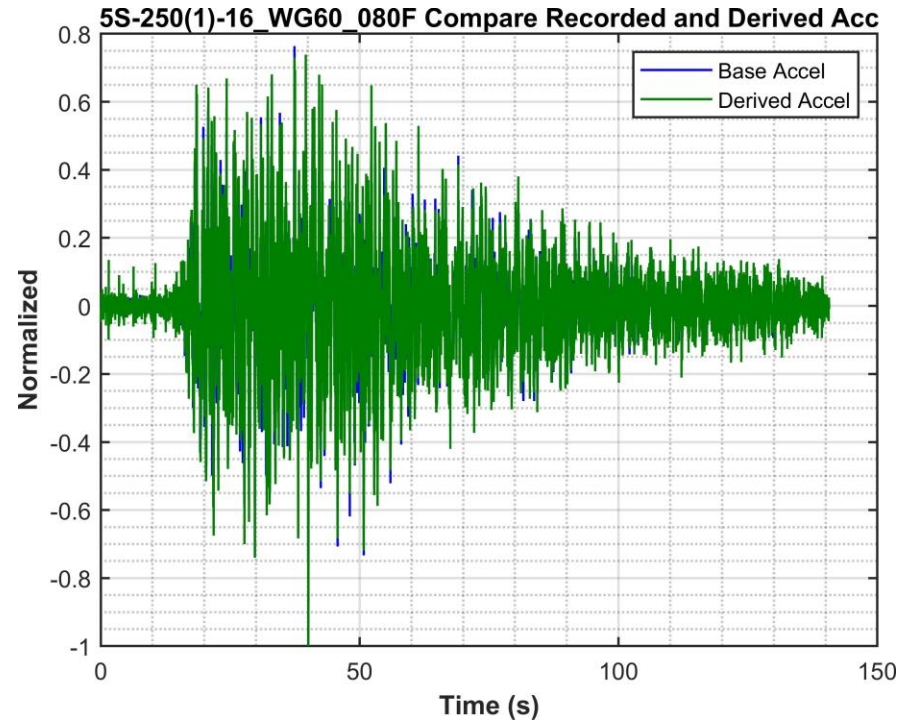
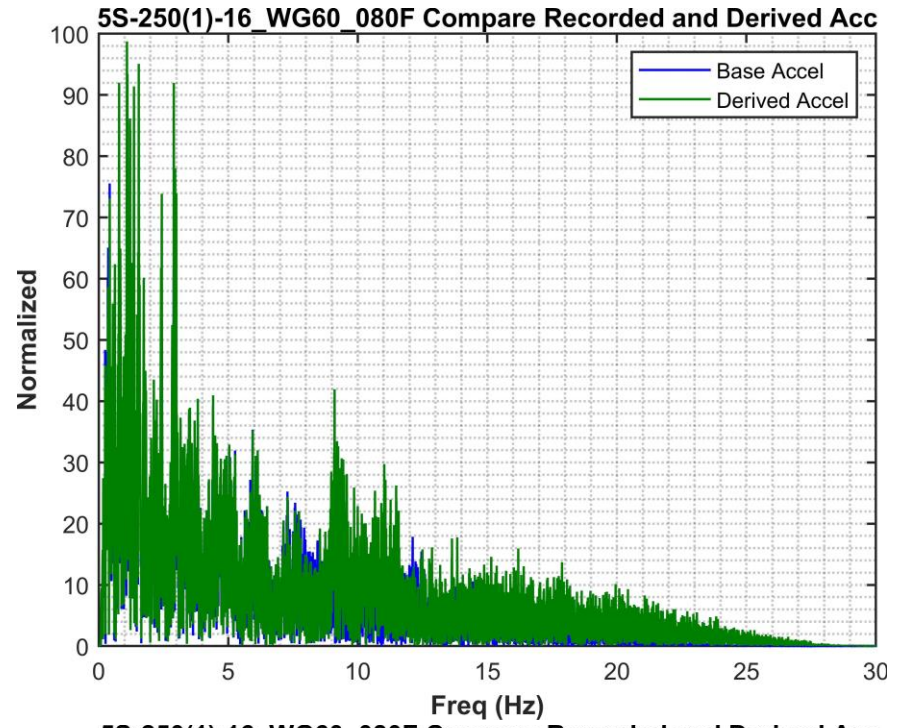
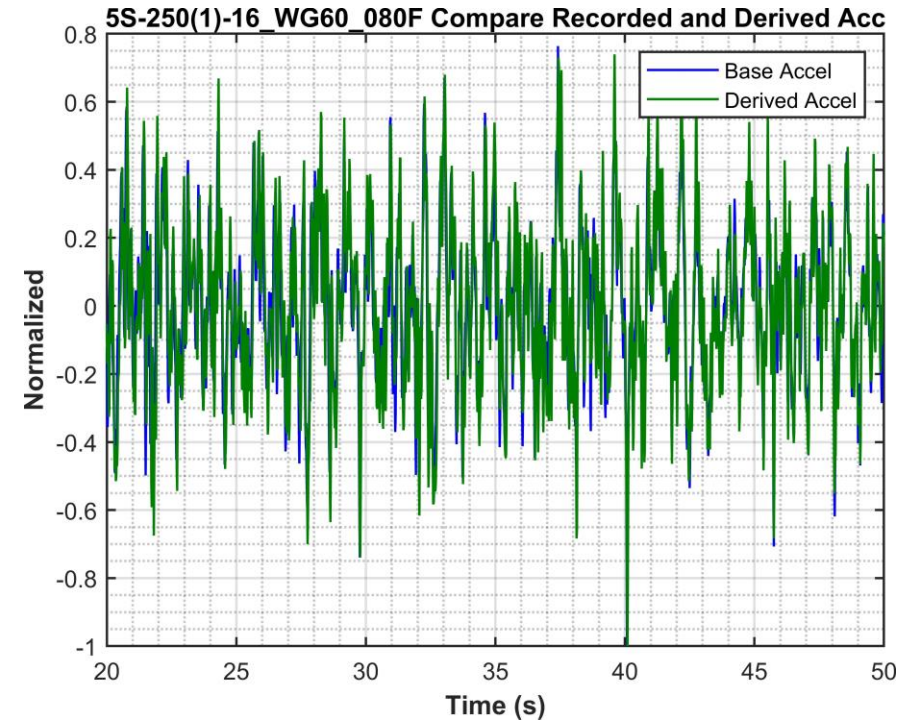
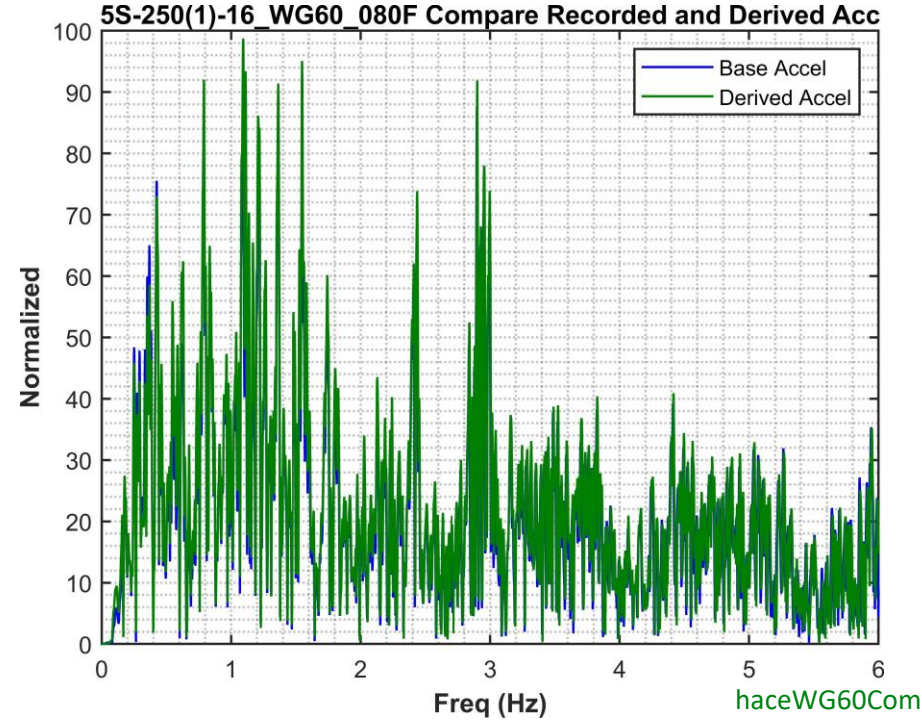
Acceleration Comparison

Base Records

Recorded acceleration is compared with derived acceleration from vision displacements

Good agreement is found for the response frequency band.

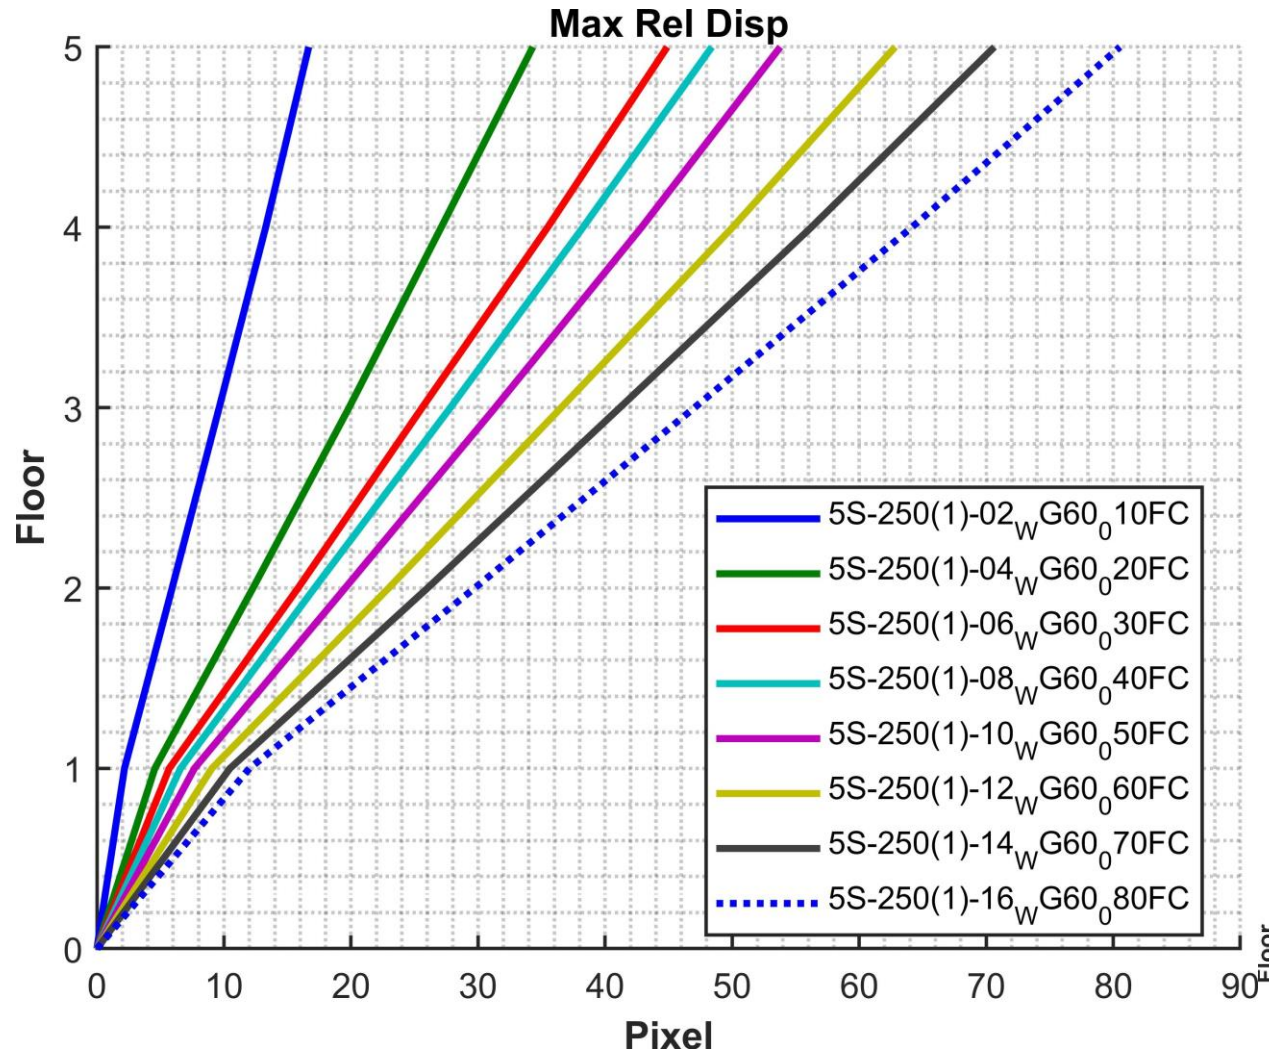
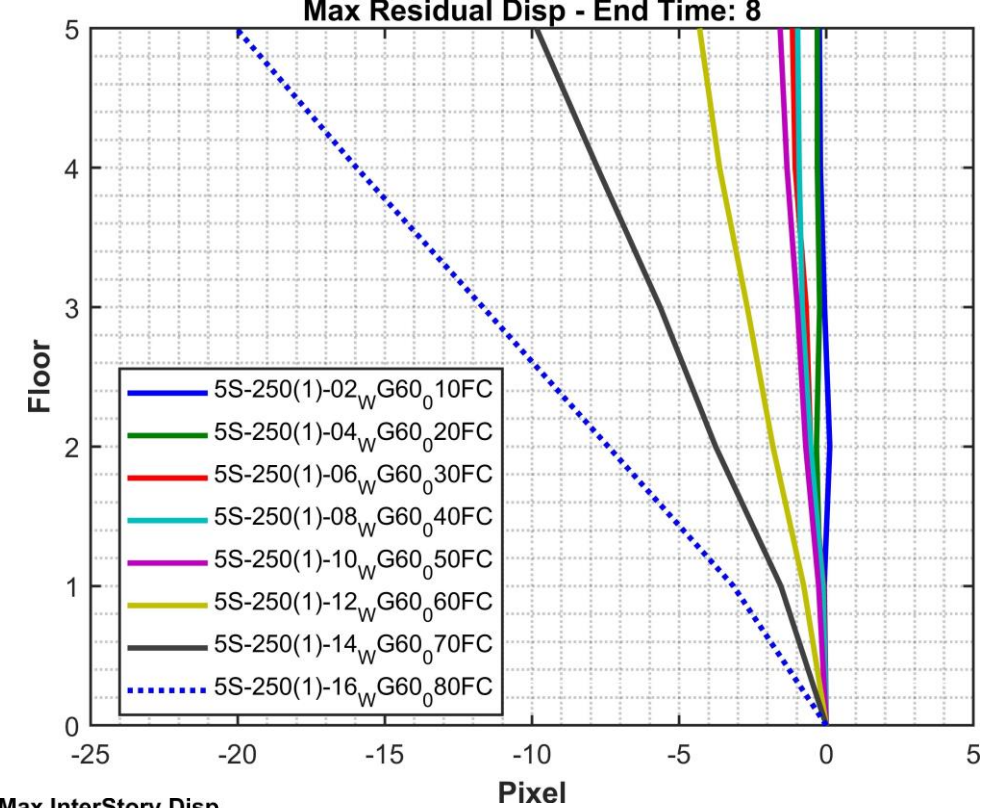
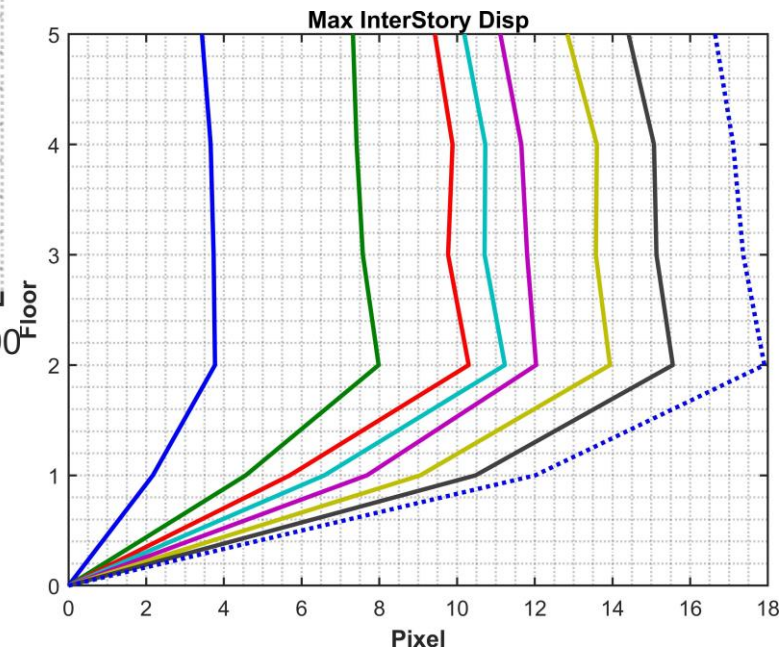
Envelopes for all Test WG60F

Total Displacement, Interstory Drift and Residual Displacements increases with demands in each test. The cumulative residual drift for all test will be the summation of results. Residual drift of less than 2 pixels is not robust.

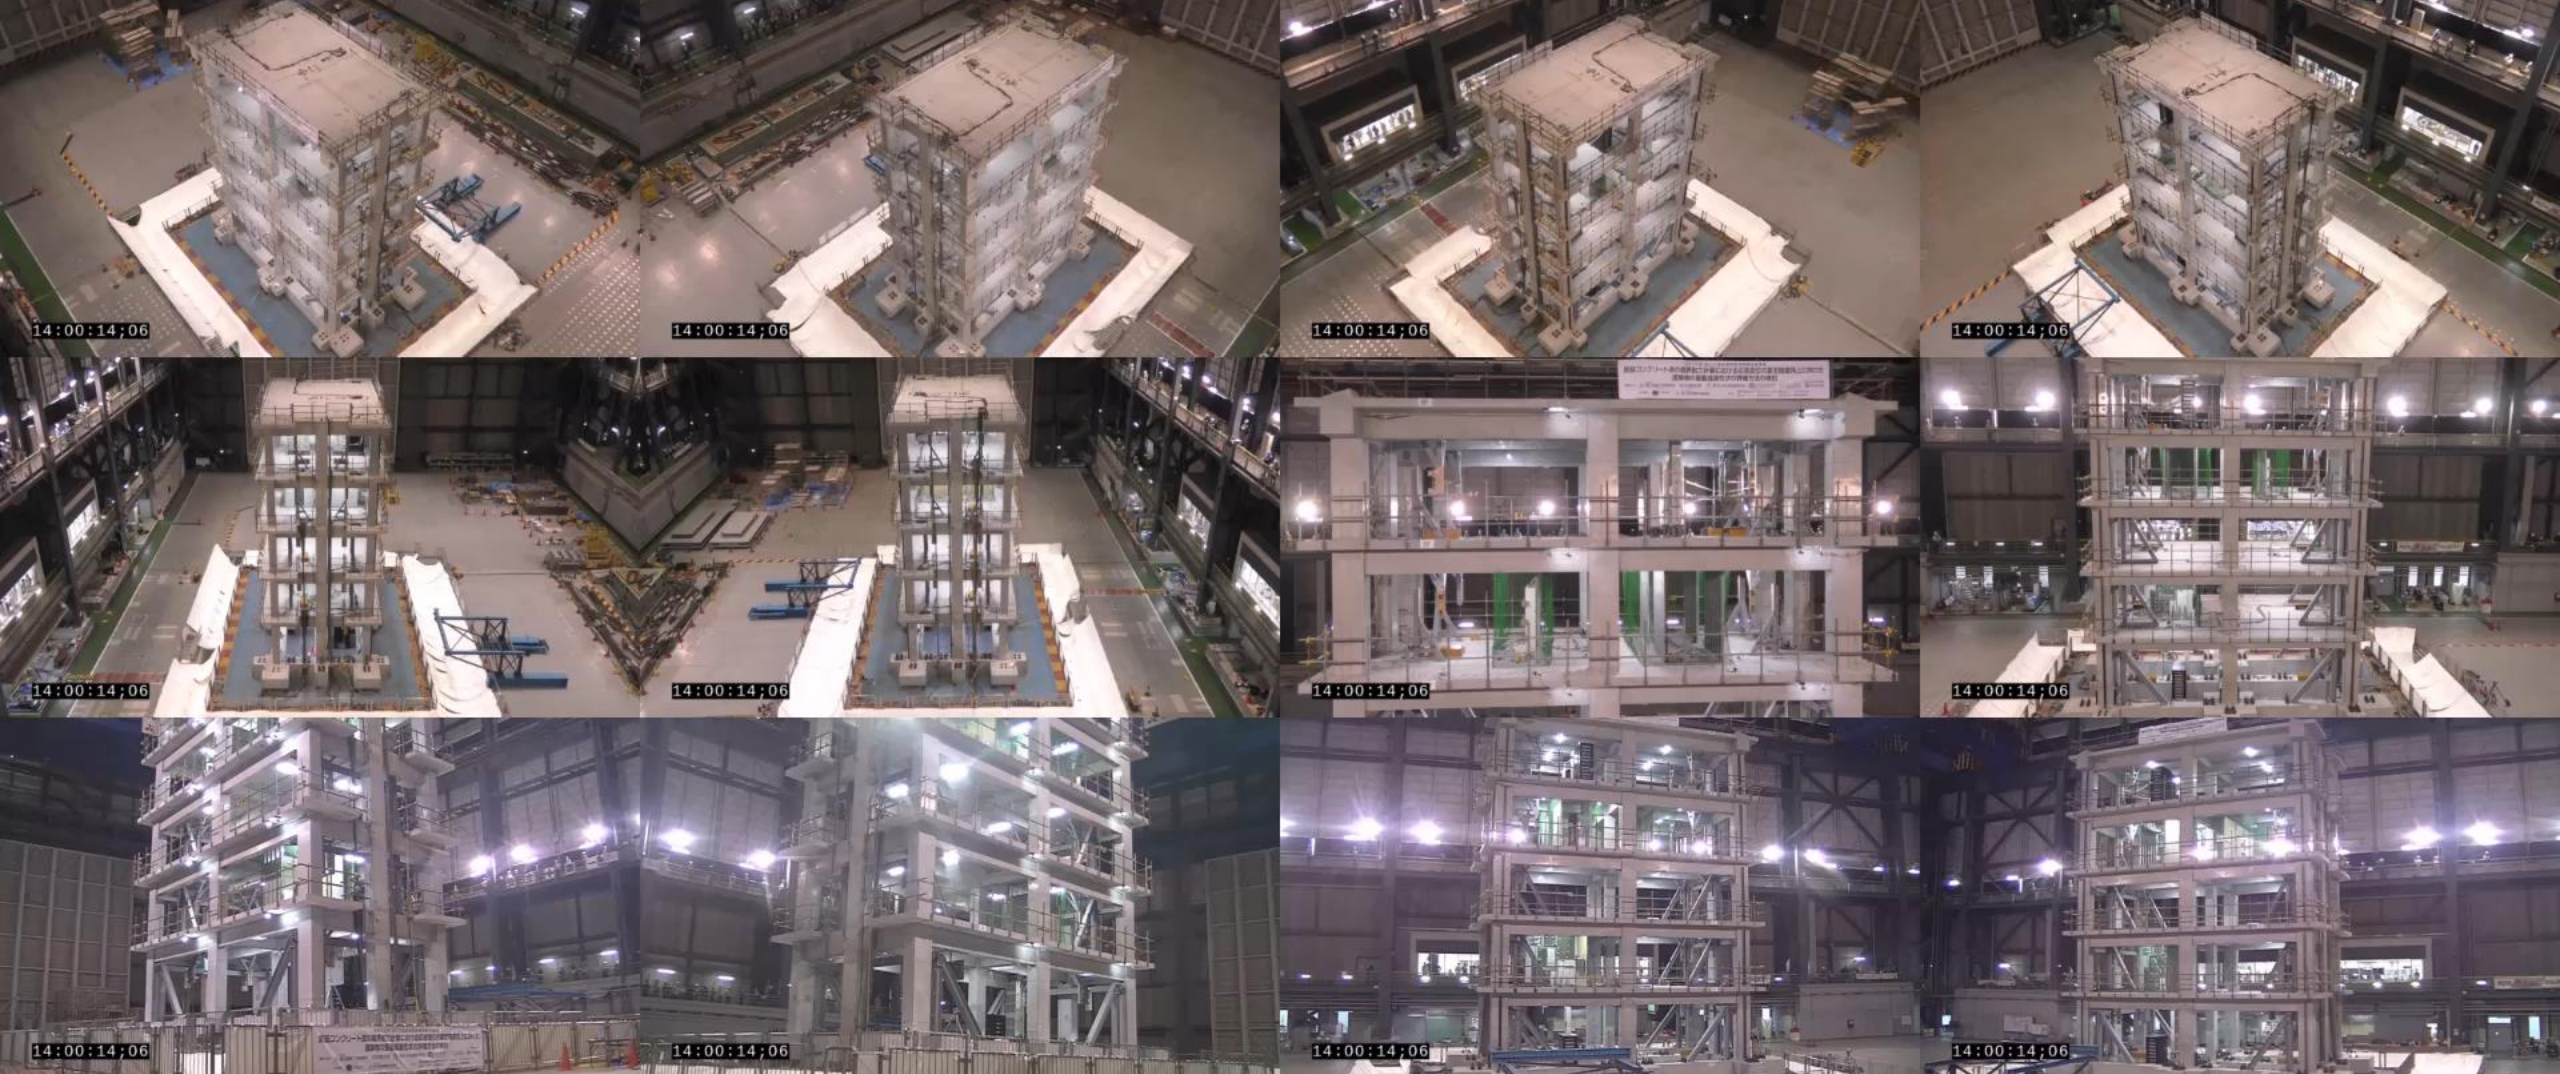
BLIND TEST: video provided by Prof. Kusunoki and Researcher T. Yeow

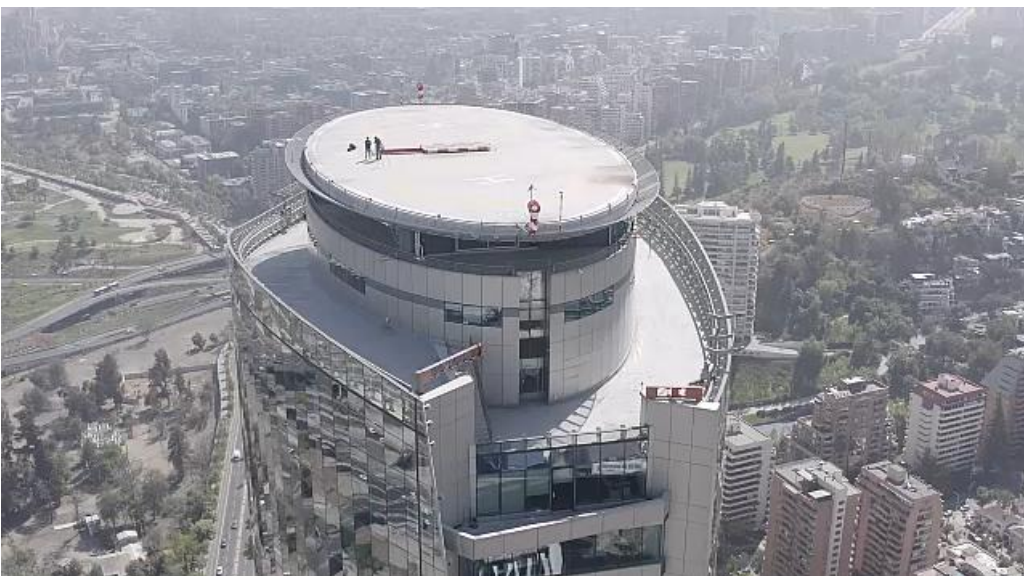
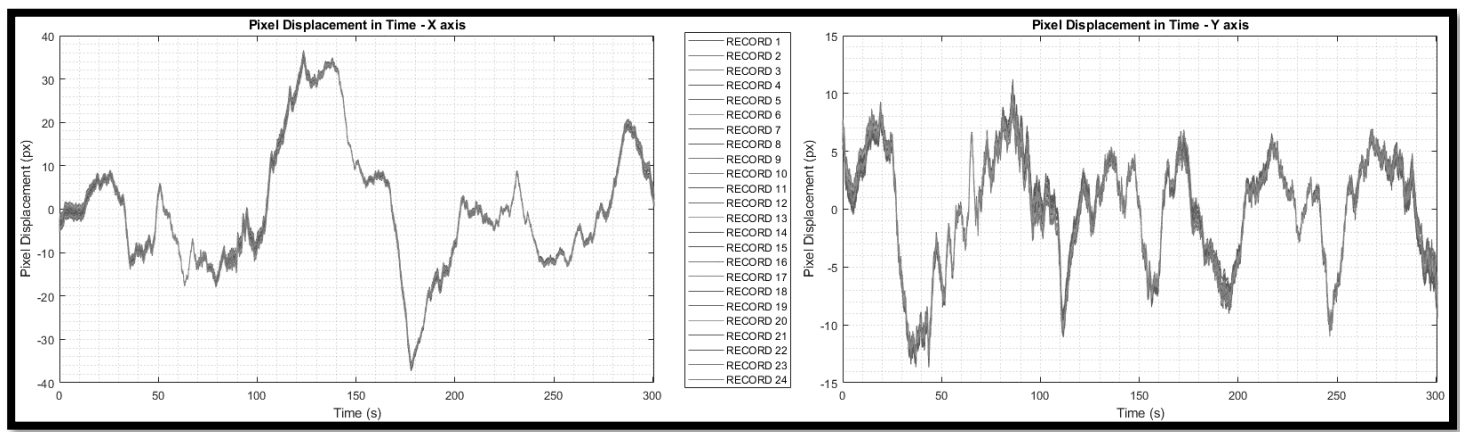
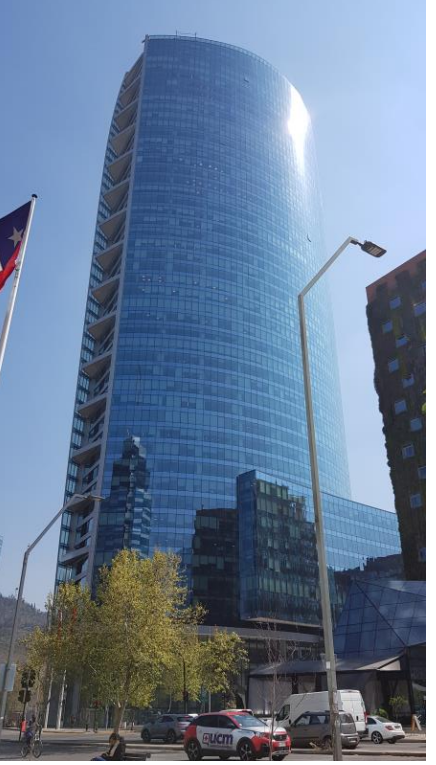
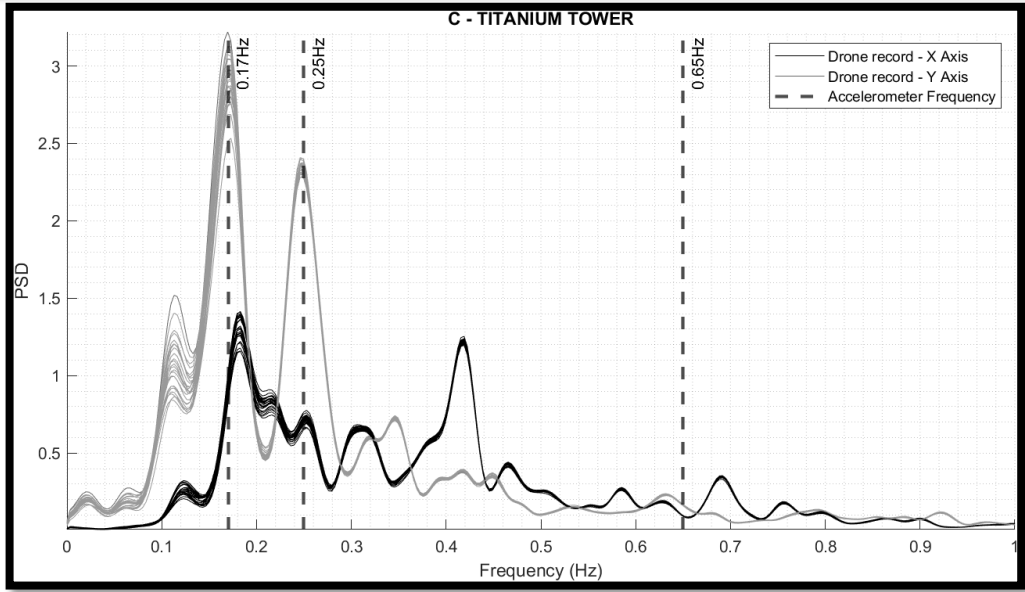
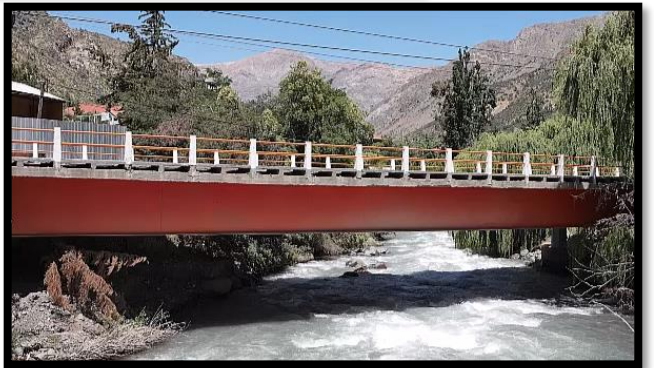
Alarcon, Felipe. Boroschek, Ruben. Dynamic response of structures under operational vibrations using drone video footage without fiducial markers. IMAC-XLI Feb 2023

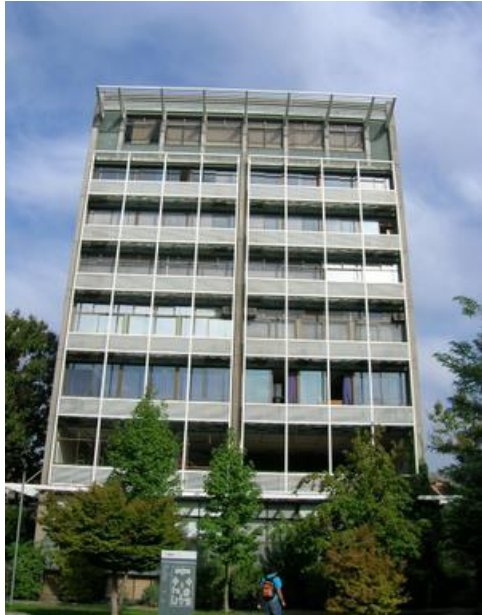
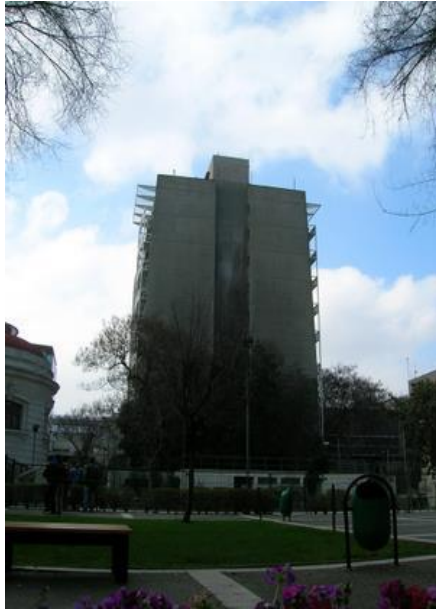
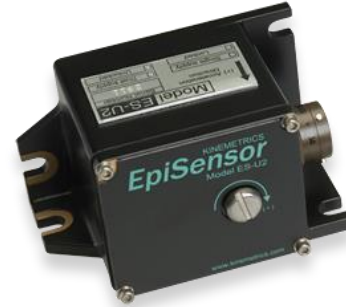
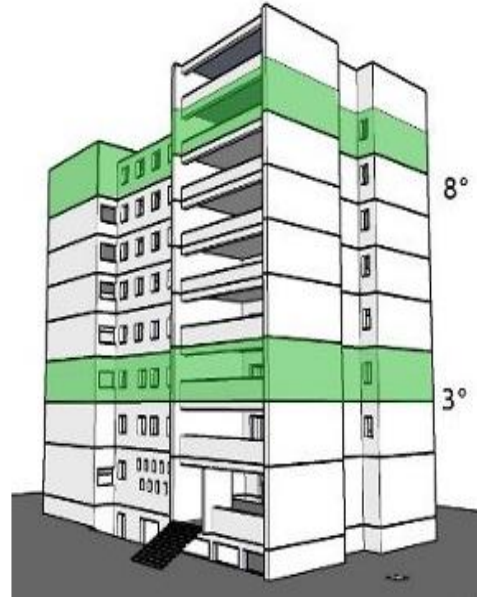
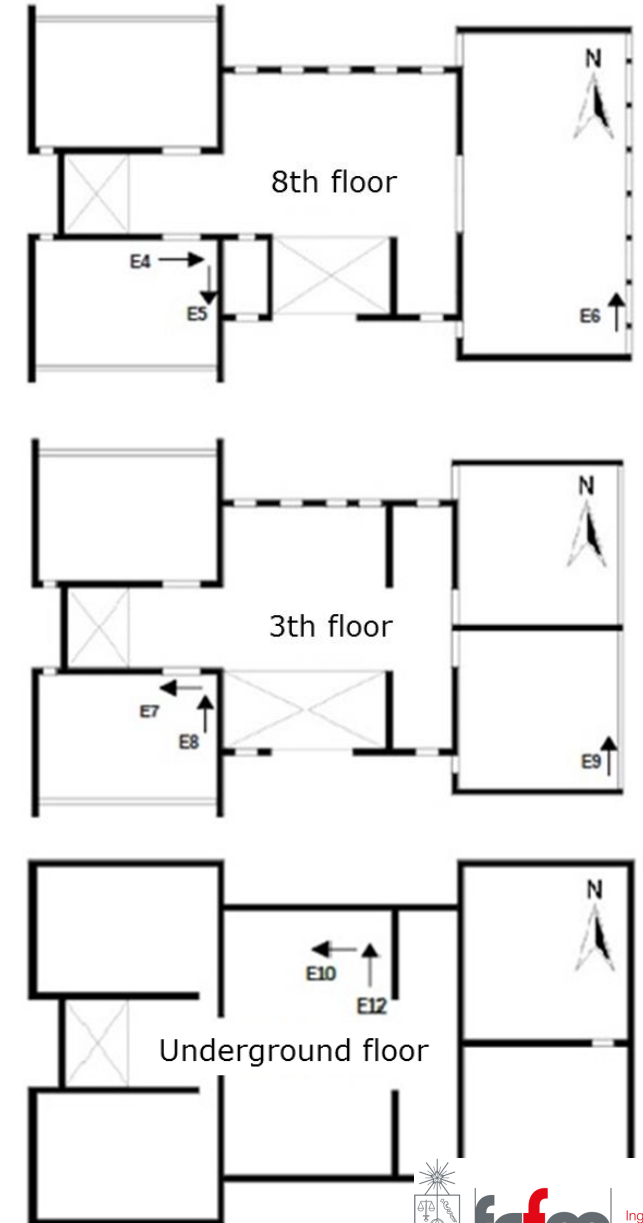
First SHM in CHILE 2009 University of Chile

- Structural Walls
- 9 Stories above ground (30.2 m).
- 2 Stories below ground (30x19 area).
- Wall thickness 35 cm.
- Slab thickness 25 cm.
