Advances in Seismic Structural Health Monitoring

Rubén Boroschek, Ph. D

**Professor
University of Chile**

**May 7
IOMAC**

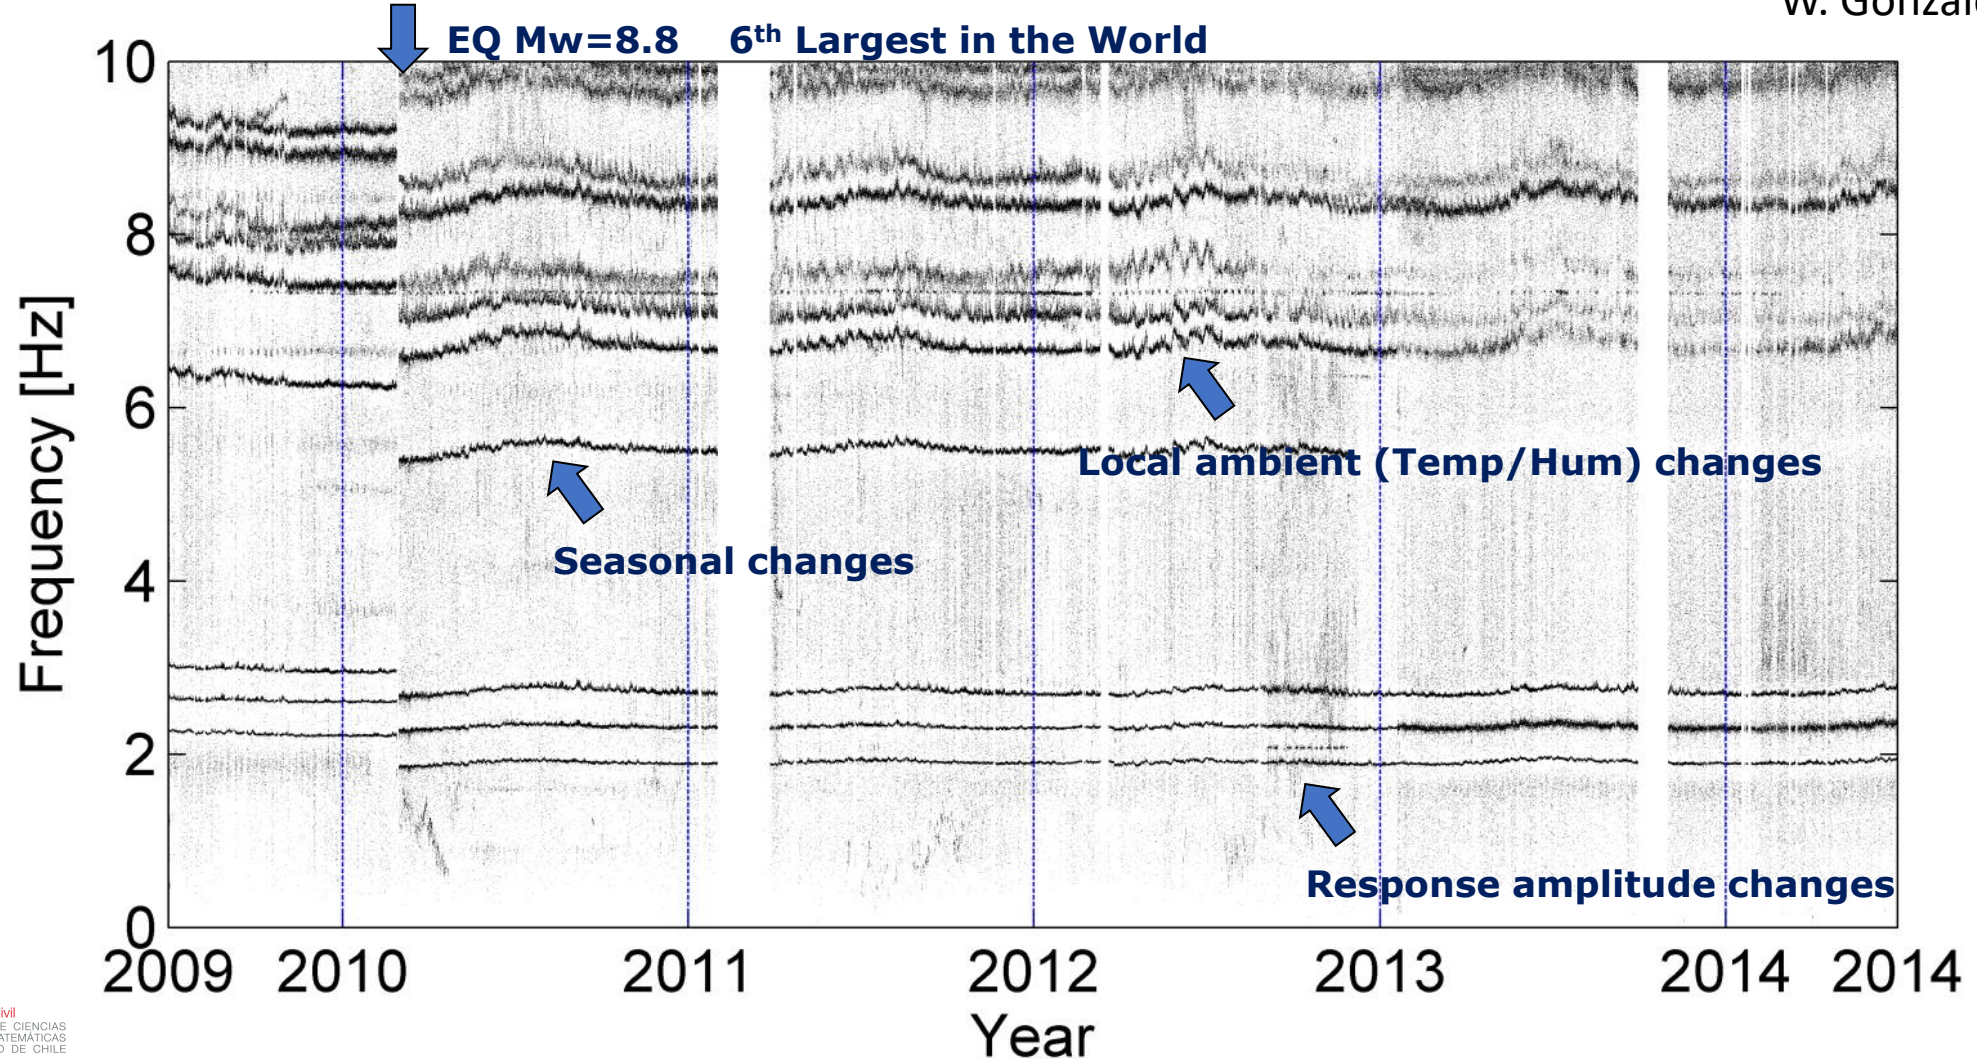
AUTOMATIC IDENTIFICATION 2009/2014

Still running: 13 years data. Modal Parameters every 15 min.

Displacement in each strong shaking

EQ 2010 damage

DAILY and SEASONAL ambient variations

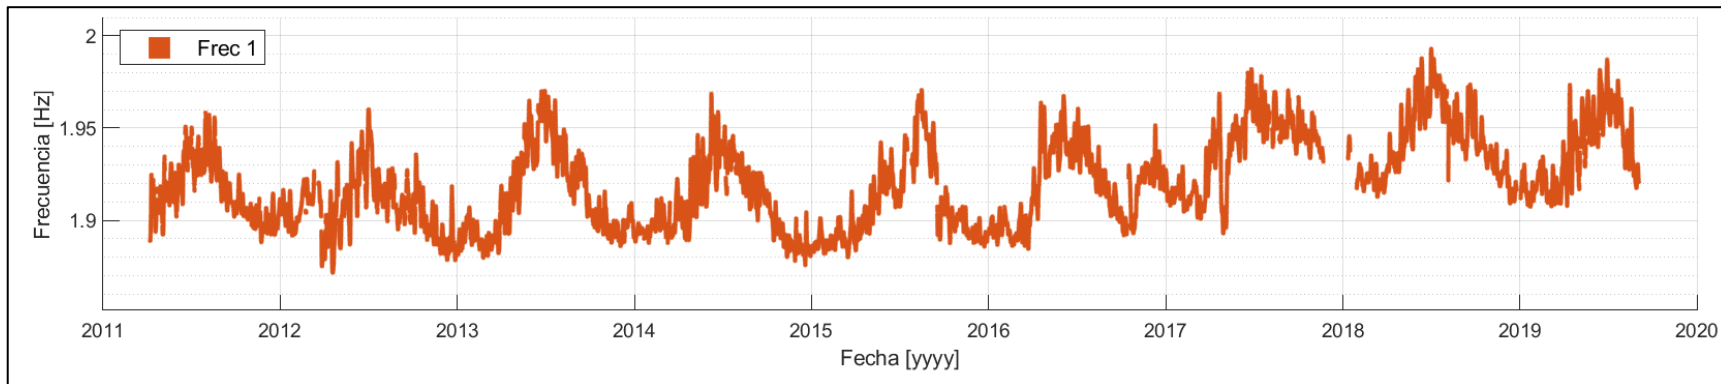
First Mode
Seasonal changes

Frequency/Temperature: Seasonal

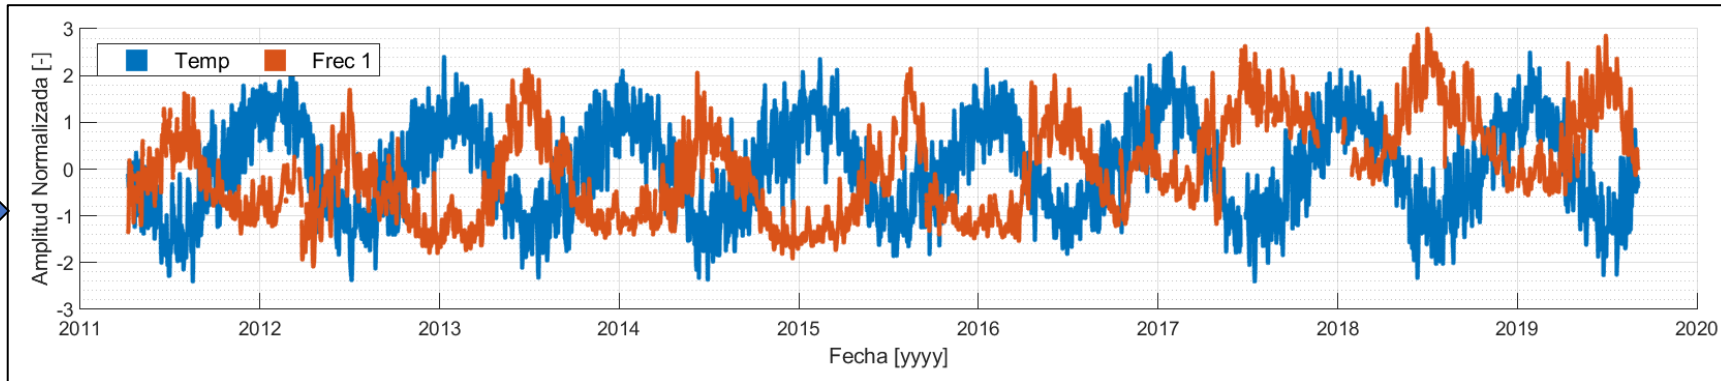
First Mode and
Temperature

Seasonal changes

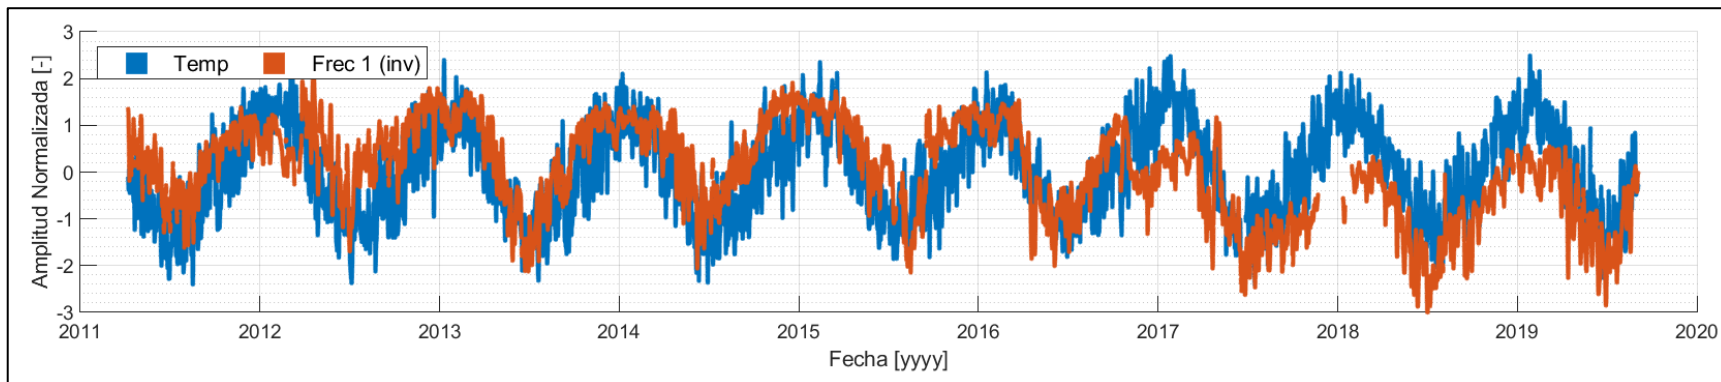
First Mode and
Temperature x (-1)

Seasonal changes

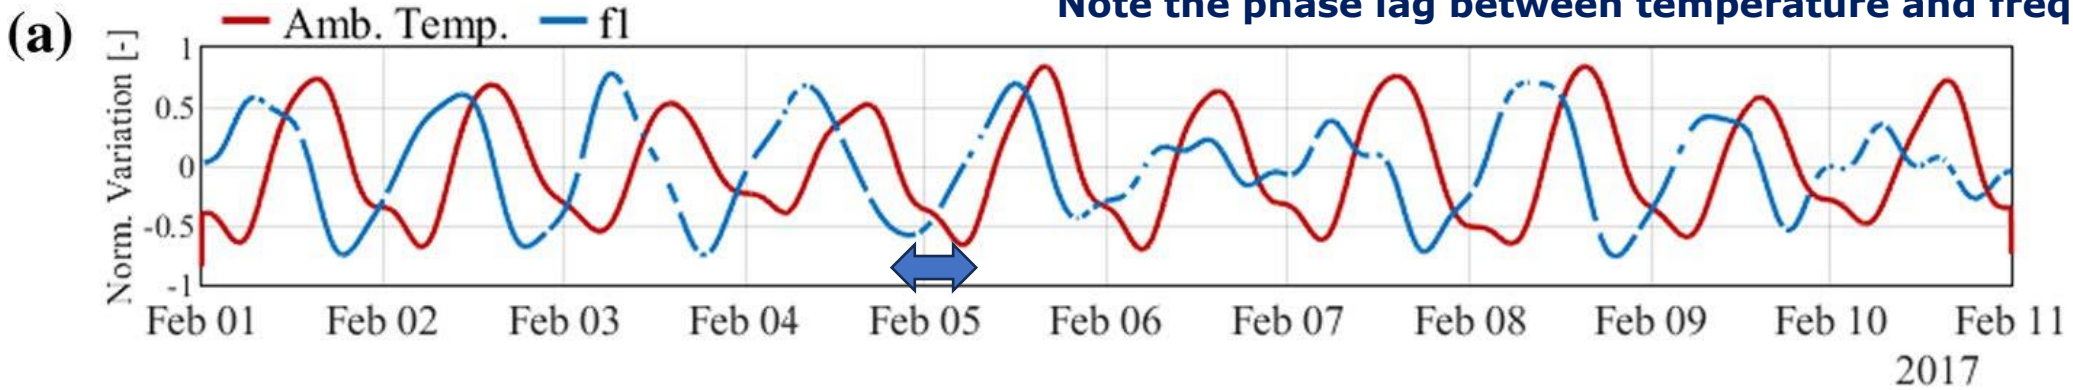
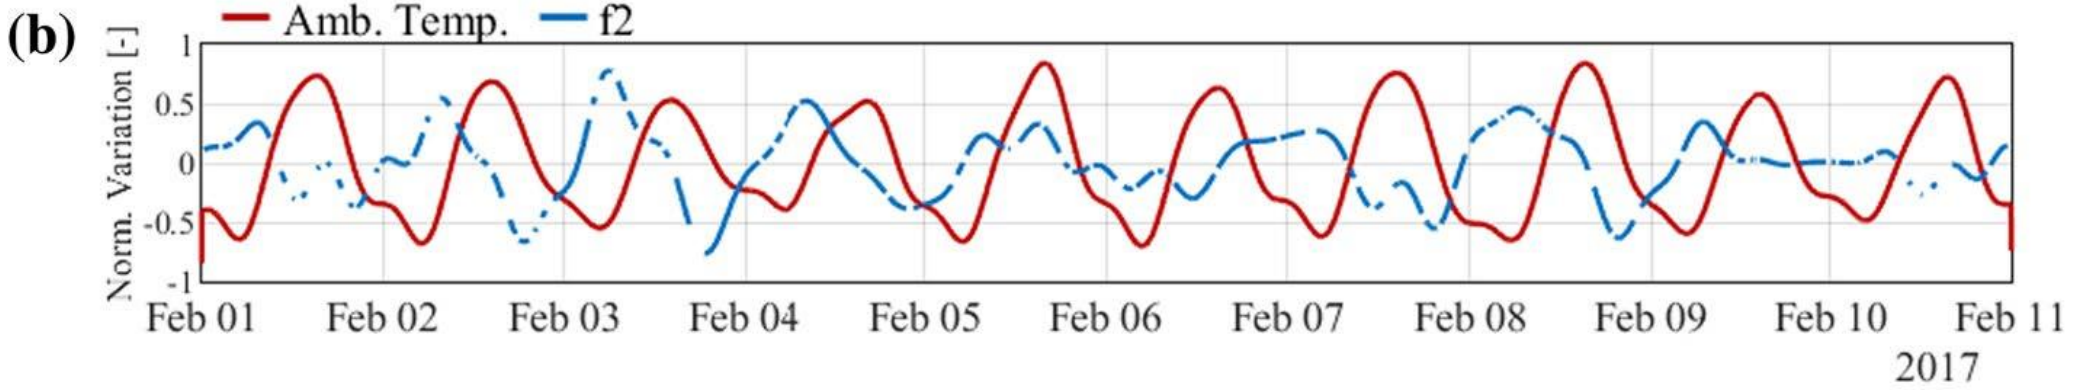
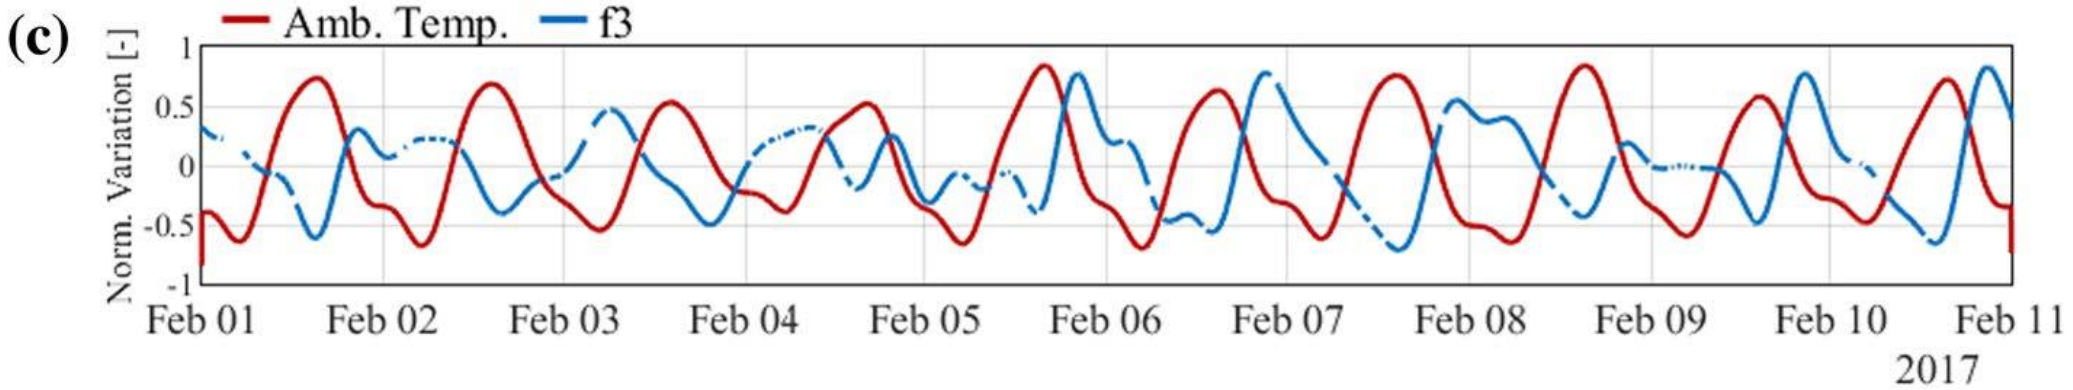
Frequency/Temperature: DAYLY

Note the phase lag between temperature and frequency

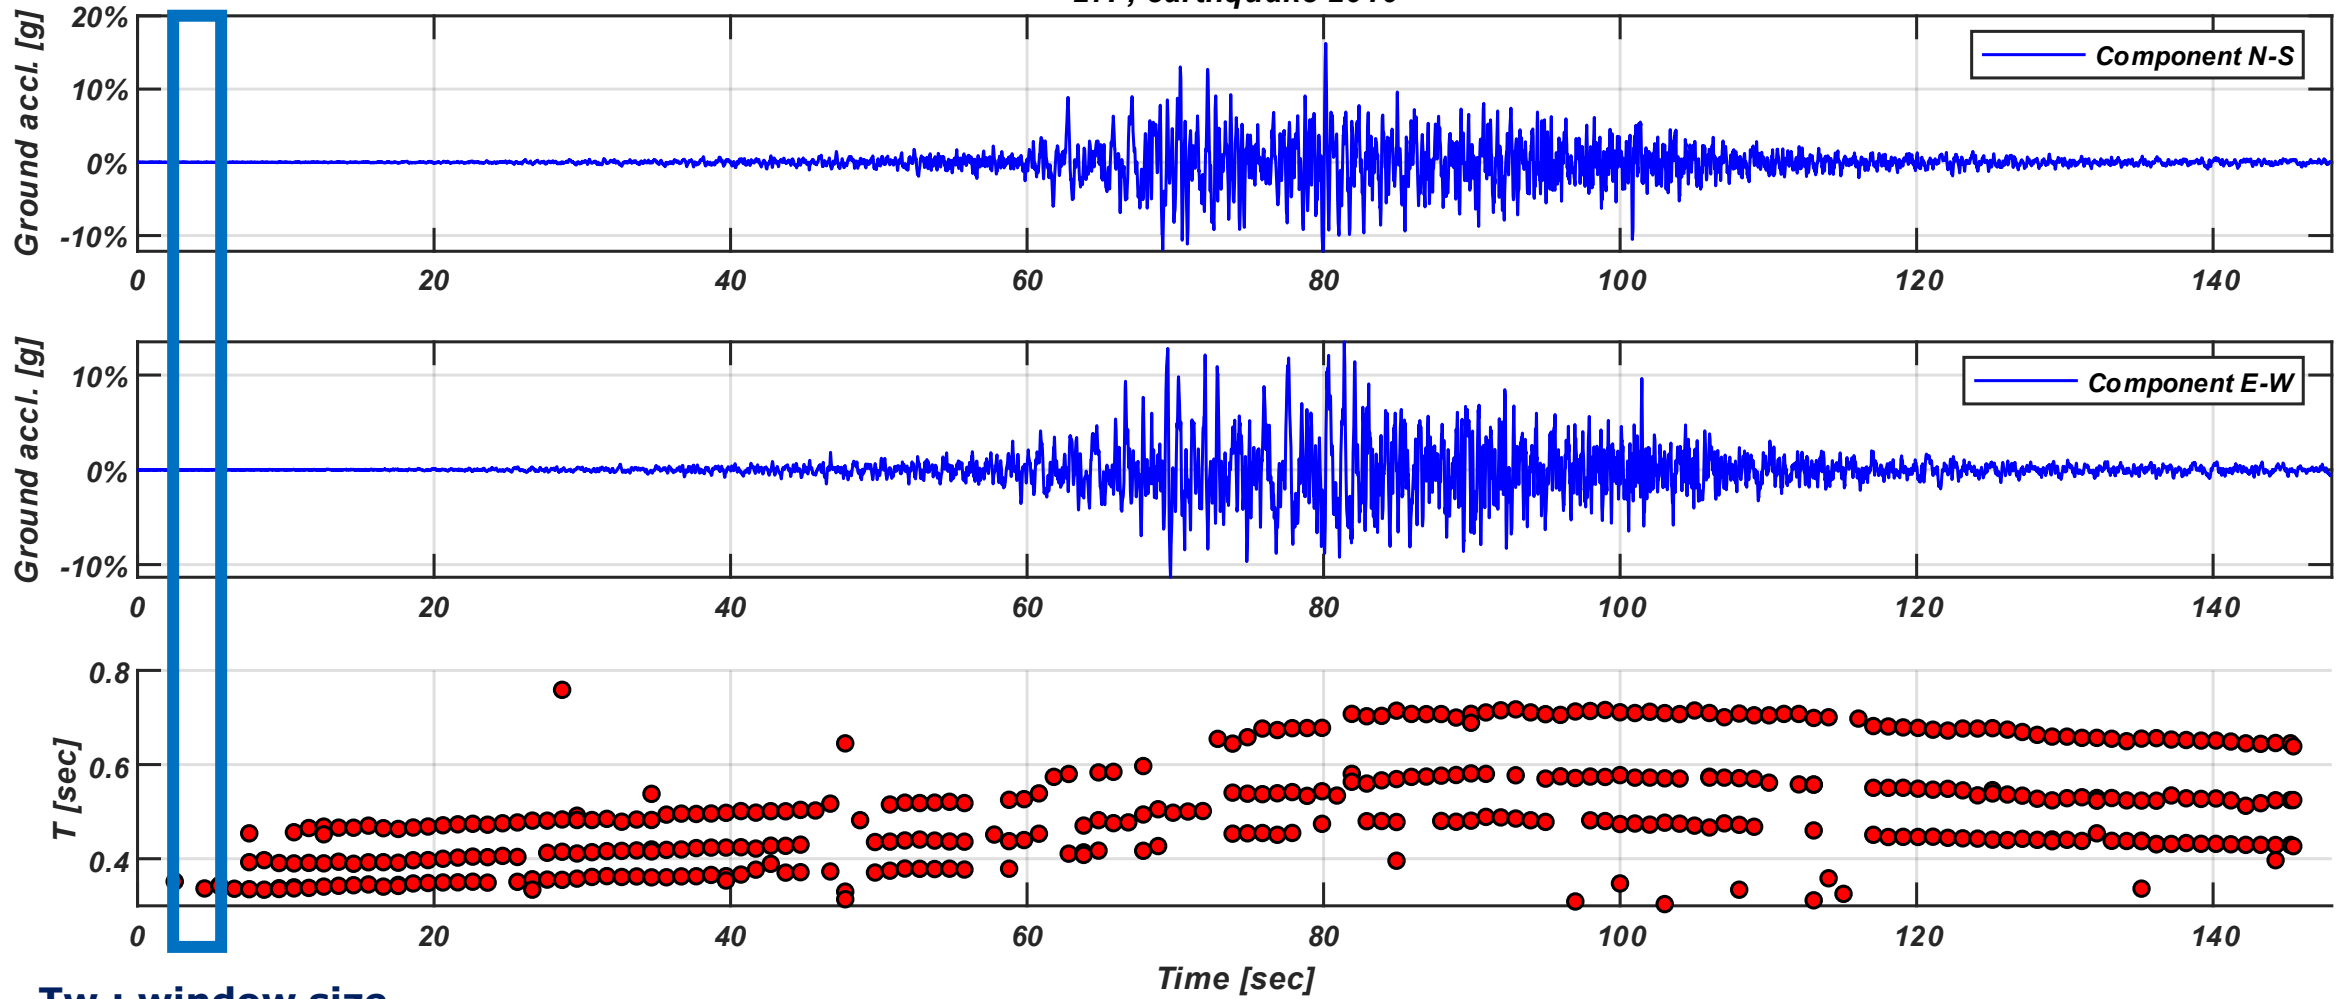
Frequency Variations Earthquakes

27F, earthquake 2010

Tw : window size

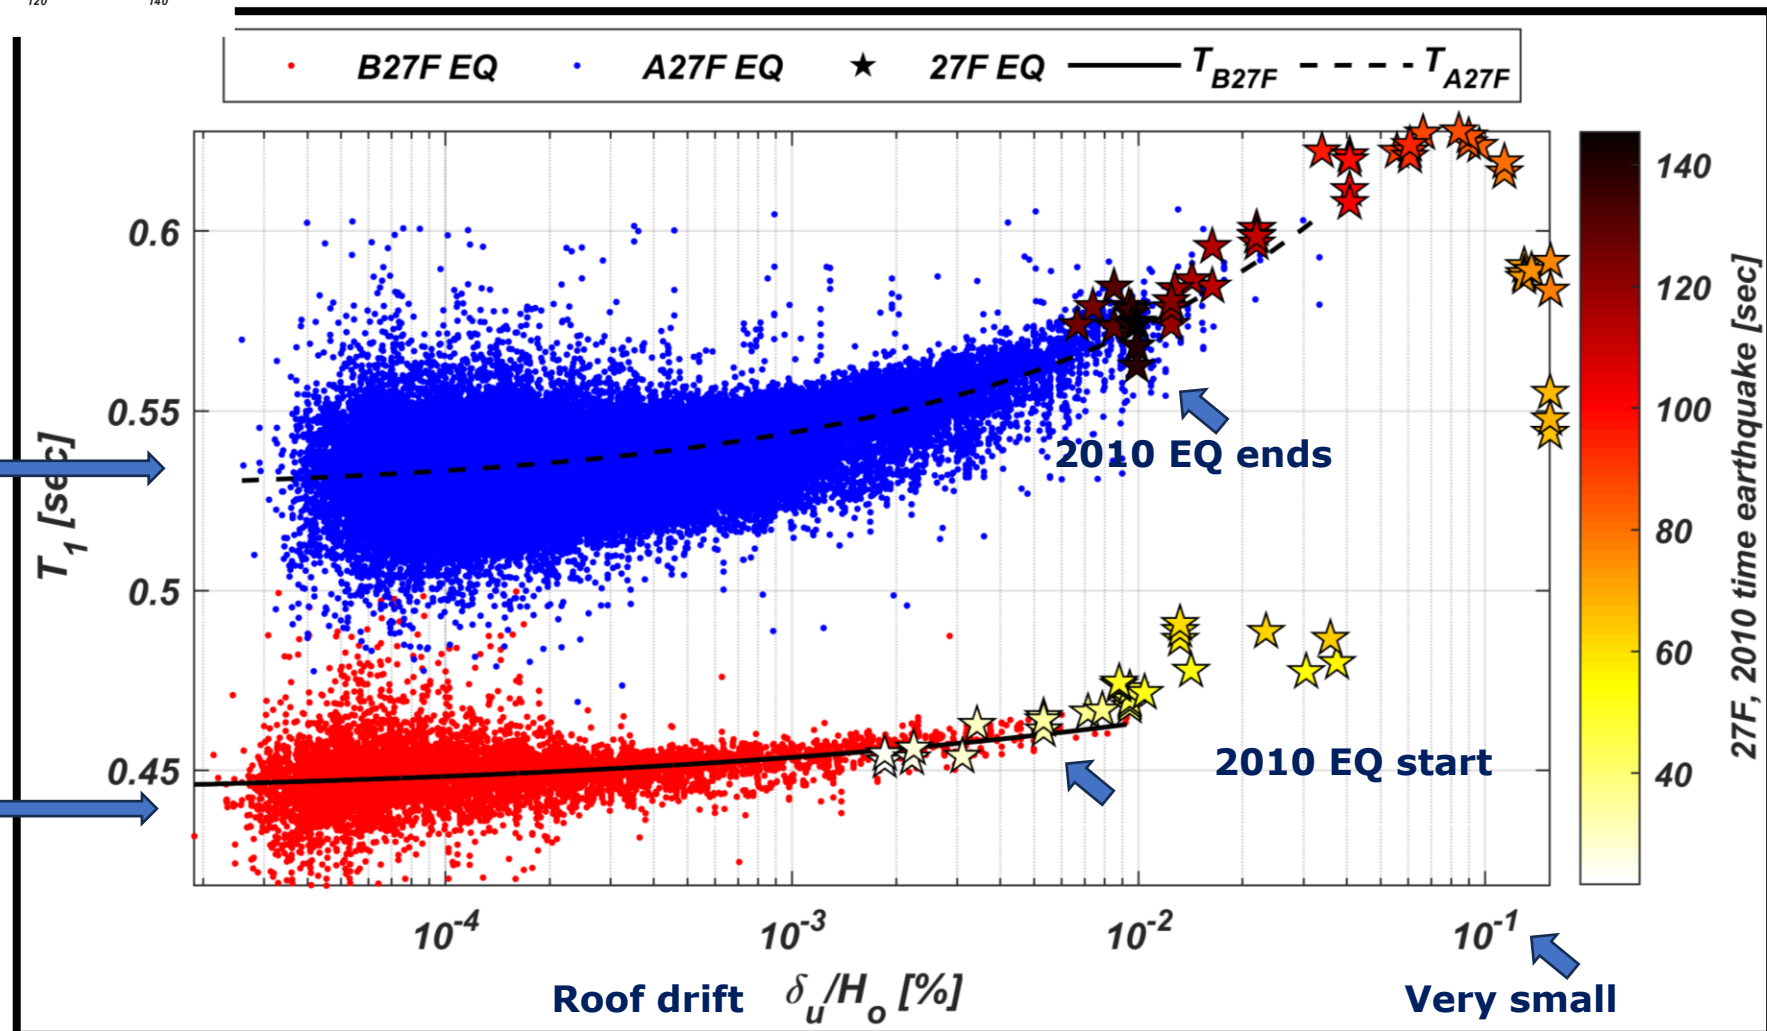
After de 2010 EQ

Before de 2010 EQ

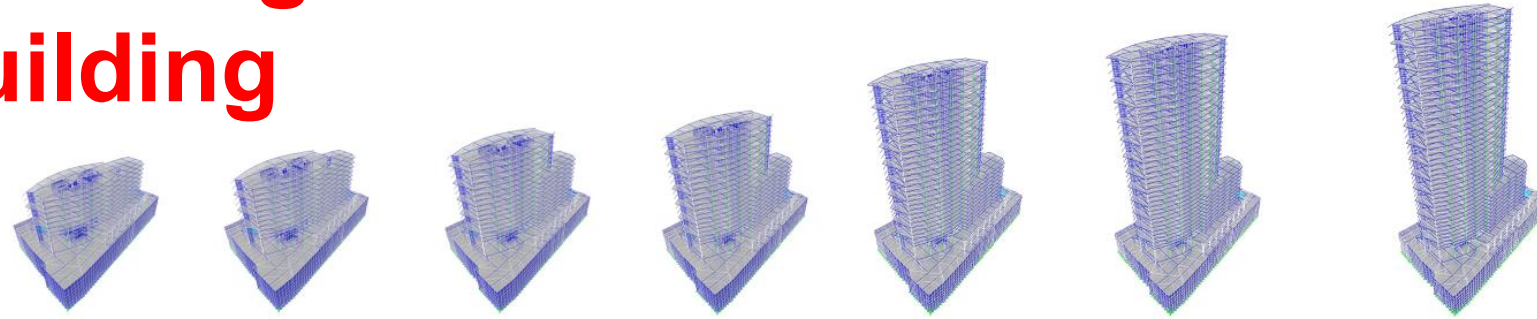
CHILE: Monitoring Under Construction Titanium Building

2 studies:

- (a) 5 month continuous under construction monitoring
- (b) Records every 2 or 3 stories during 5 construction stages

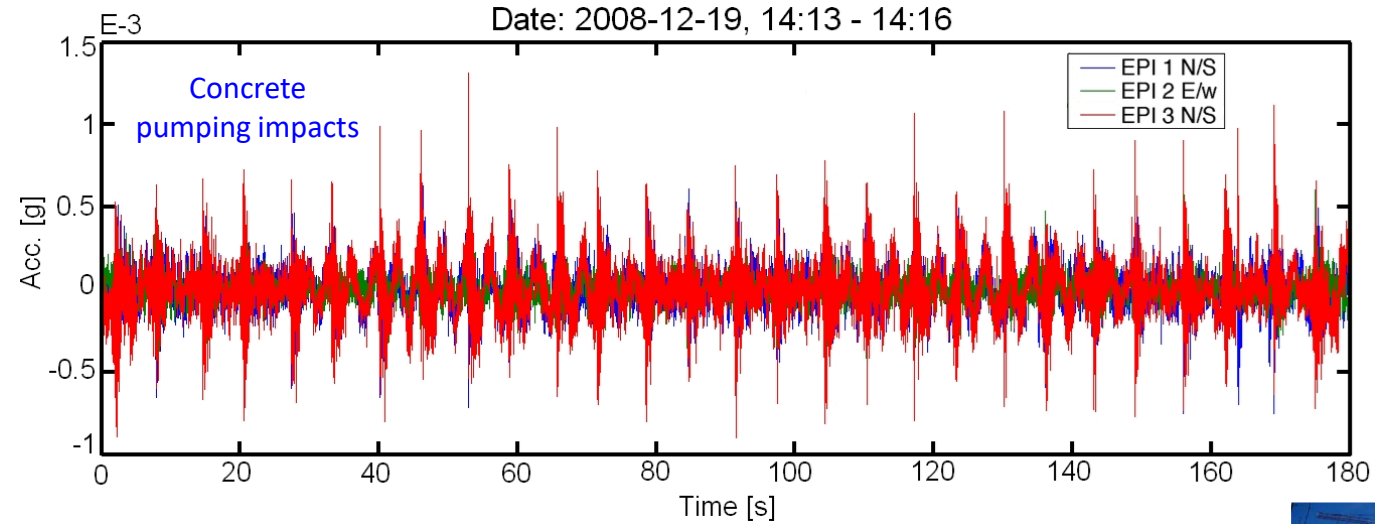
Construction Process: Monitoring Difficulties

- High transient vibration due to impact.
- Continuous and permanent variations of mass and stiffness.
- Operation of small and large machinery like cranes, concrete pumping and others.

All this activities affects the system identification processes producing nonstationary signals

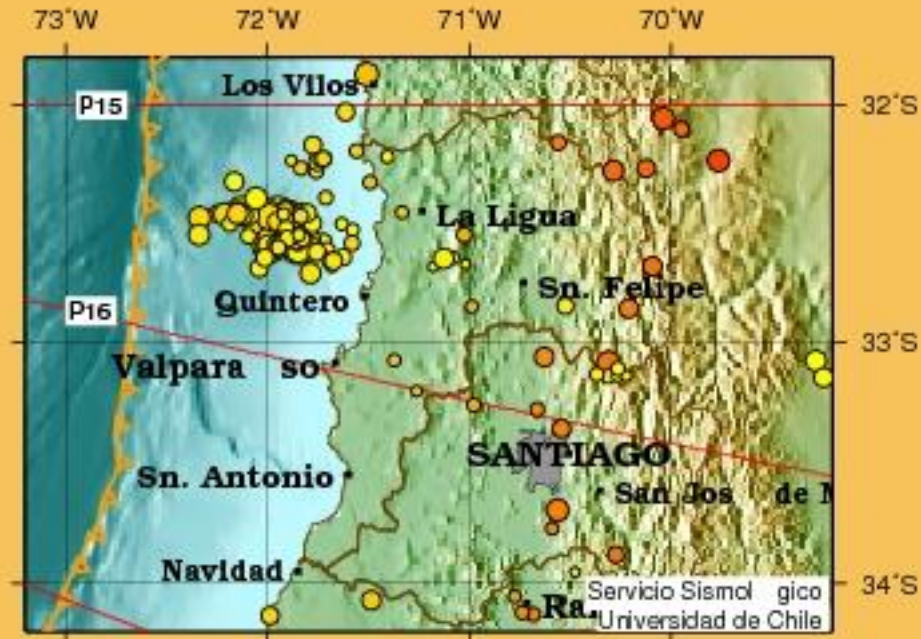
Earthquakes During Monitoring

Date	Time	Lat	Long	Depth	Mag
1	18-12-2008	18:19:28	-32 28' 33"	-71 54' 00"	24.0	5.9
2	18-12-2008	18:25:02	-32 29' 24"	-71 52' 37"	37.7	4.6
3	18-12-2008	18:50:28	-32 28' 44"	-72 04' 15"	25.1	5.5
4	19-12-2008	0:04:16	-32 29' 27"	-71 54' 50"	26.7	4.5
5	19-12-2008	4:30:06	-32 32' 20"	-72 01' 19"	12.0	5.1
6	19-12-2008	6:36:04	-32 27' 28"	-71 56' 56"	32.2	5.8
7	19-12-2008	10:57:30	-32 35' 02"	-71 51' 07"	13.8	5.1
8	19-12-2008	13:48:49	-32 35' 41"	-72 00' 21"	6.0	4.9
9	19-12-2008	14:43:26	-32 36' 43"	-71 49' 47"	29.5	4.2
10	19-12-2008	16:25:54	-32 34' 30"	-71 48' 21"	14.1	4.9
11	19-12-2008	18:33:10	-32 33' 07"	-71 57' 25"	32.0	4.4

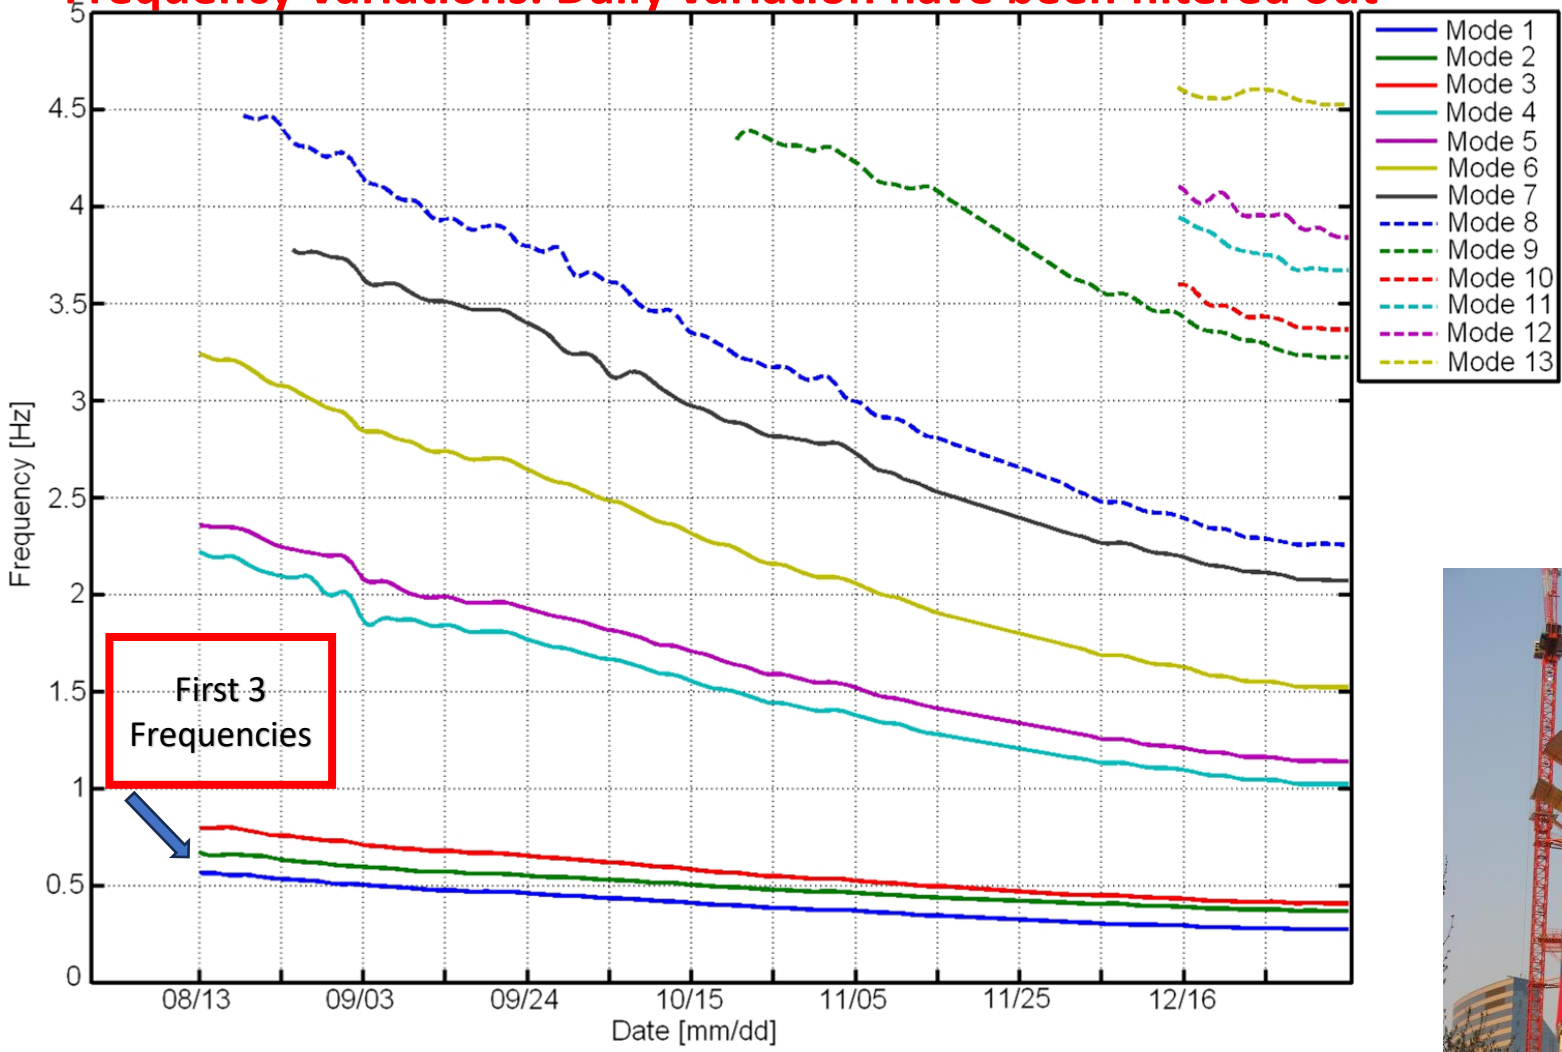
Frequency Variations. Daily variation have been filtered out

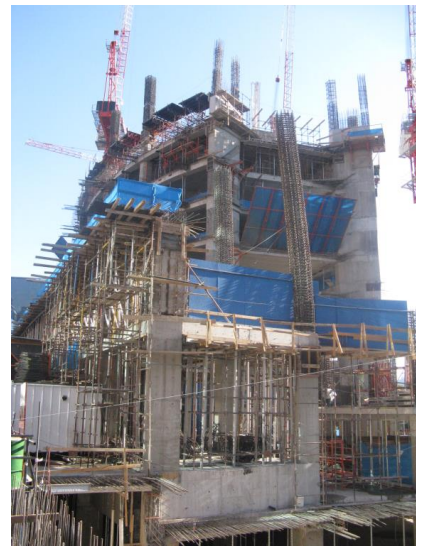
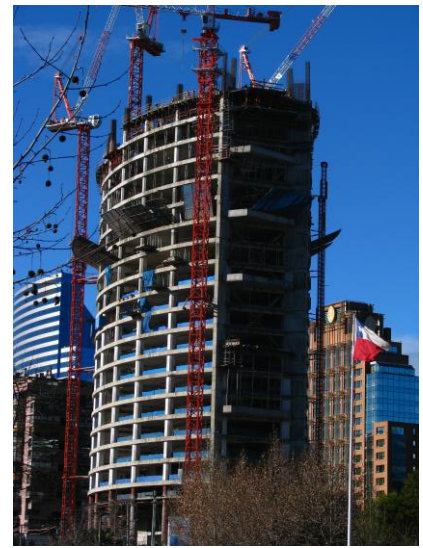
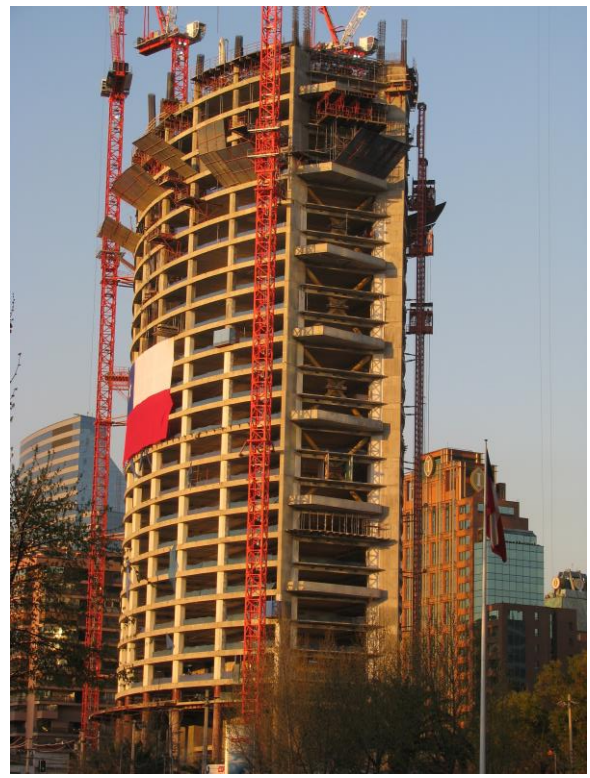
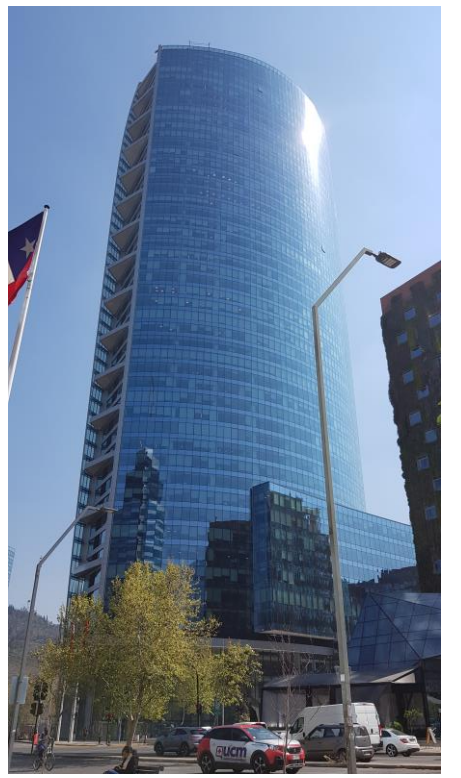
Weekly pattern (construction of 1 story)

Weekly Variations Range: [1.5 - 5.5]%
(respect to the frequency at the beginning of each week)

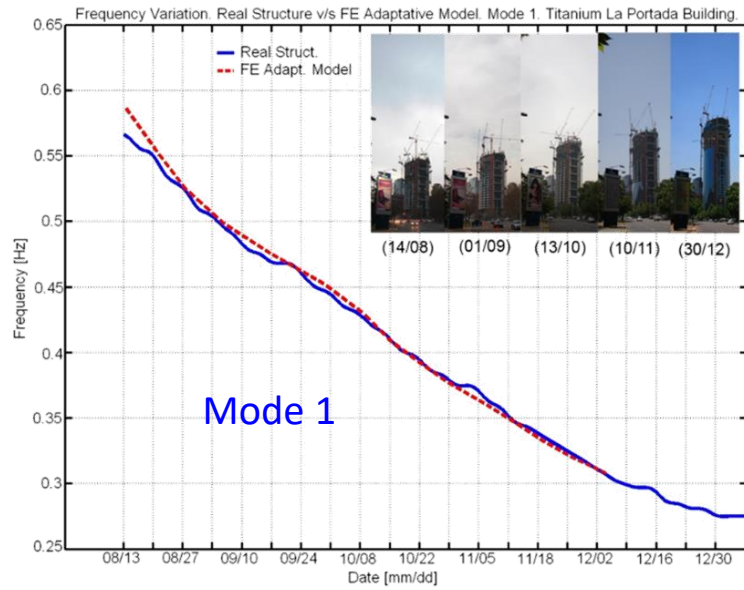
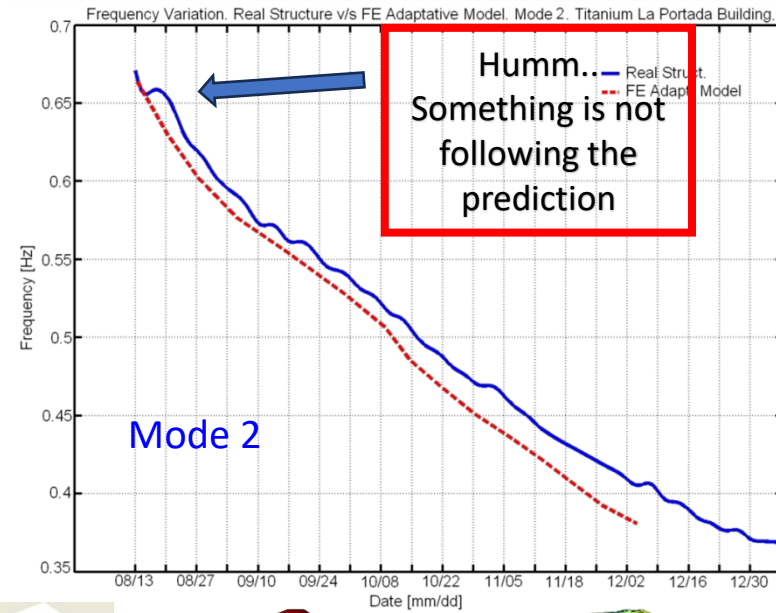
Comparison Finite Element Design Model - Adaptive Models.

Source: MACEC 3.0

f1 = 0.187 [Hz]

f2 = 0.256 [Hz]

f3 = 0.297 [Hz]

f4 = 0.713 [Hz]

f5 = 0.864 [Hz]

Source: ETABS

f2 = 0.250 [Hz]

f3 = 0.288 [Hz]

f4 = 0.700 [Hz]

f5 = 0.811 [Hz]

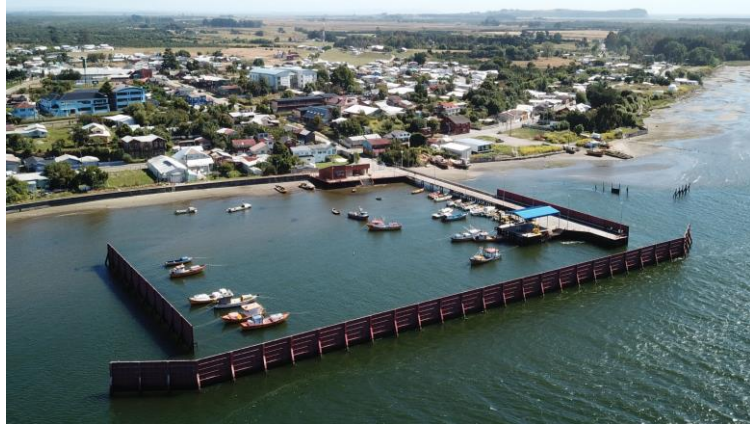
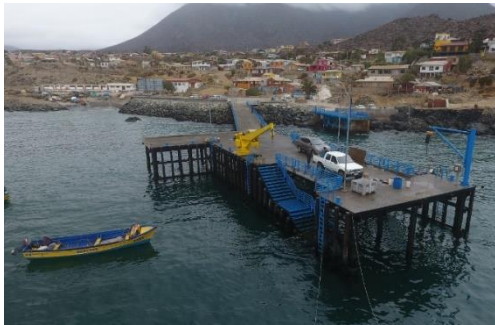
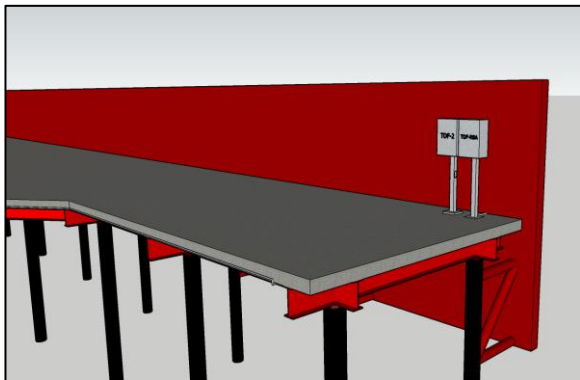
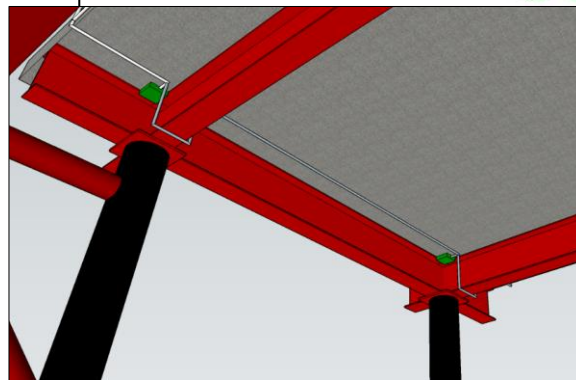
MODAL TRACKING OF TWO WHARF STRUCTURES UNDER ENVIRONMENTAL, OPERATIONAL AND EARTHQUAKE LOADS

R. Boroschek, E. Pena, P. Villalpando, N. Novoa. Modal Tracking of two wharf structures under environmental, operations and earthquake loads. IOMAC International Operational Modal Analysis Conference, Copenhagen, Denmark 13-15 May 2019.

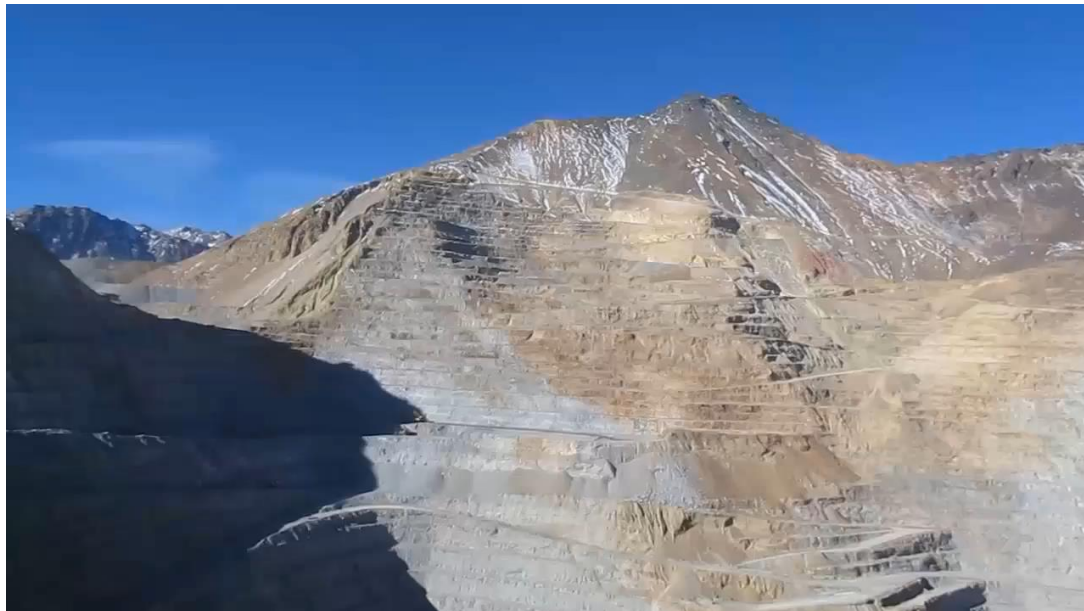
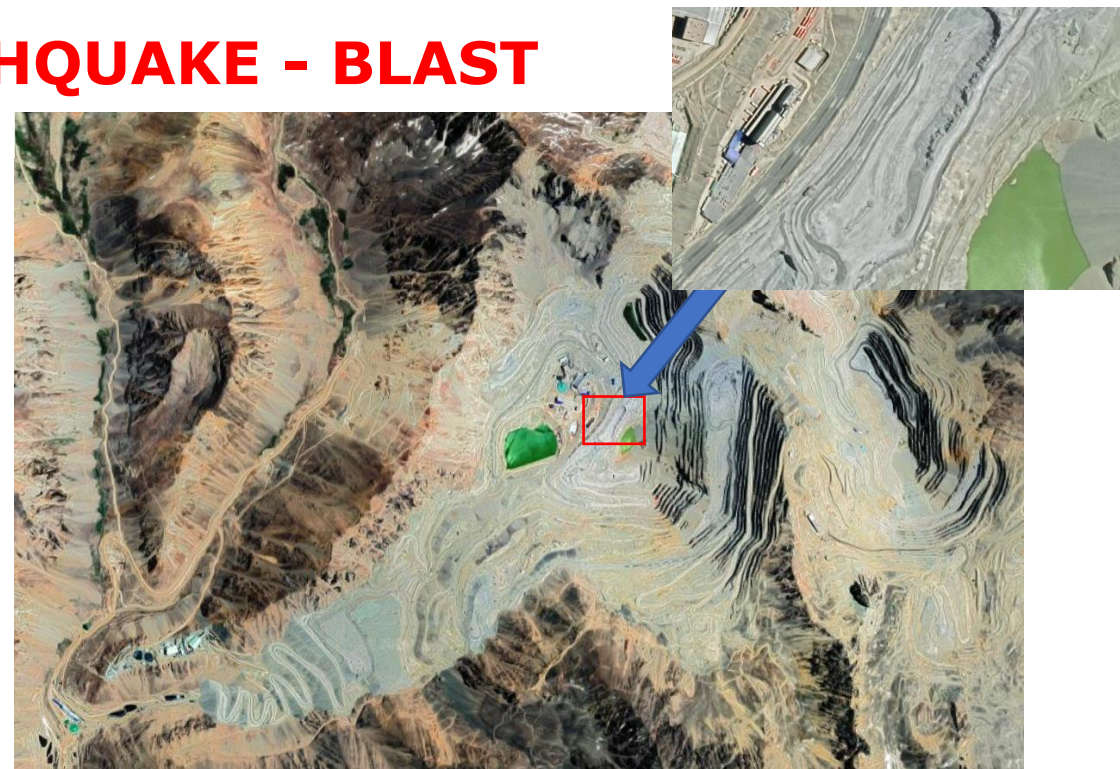
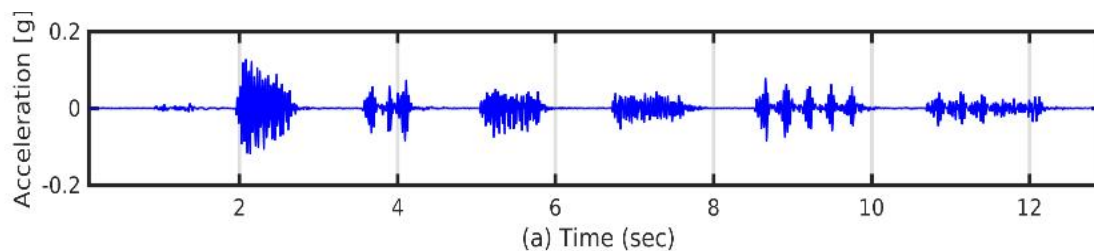
CHILE: OPERATION – EARTHQUAKE - BLAST

Blast Distance: 25–1500m
Charge: 16 – 850 kTon

Boroschek R., Villalpando P., Peña E. (2019) Building Structural Health Monitoring Under Earthquake and Blasting Loading: The Chilean Experience. In: Limongelli M., Çelebi M. (eds) Seismic Structural Health Monitoring. Springer Tracts in Civil Engineering. Springer, Cham. pp 361-383.

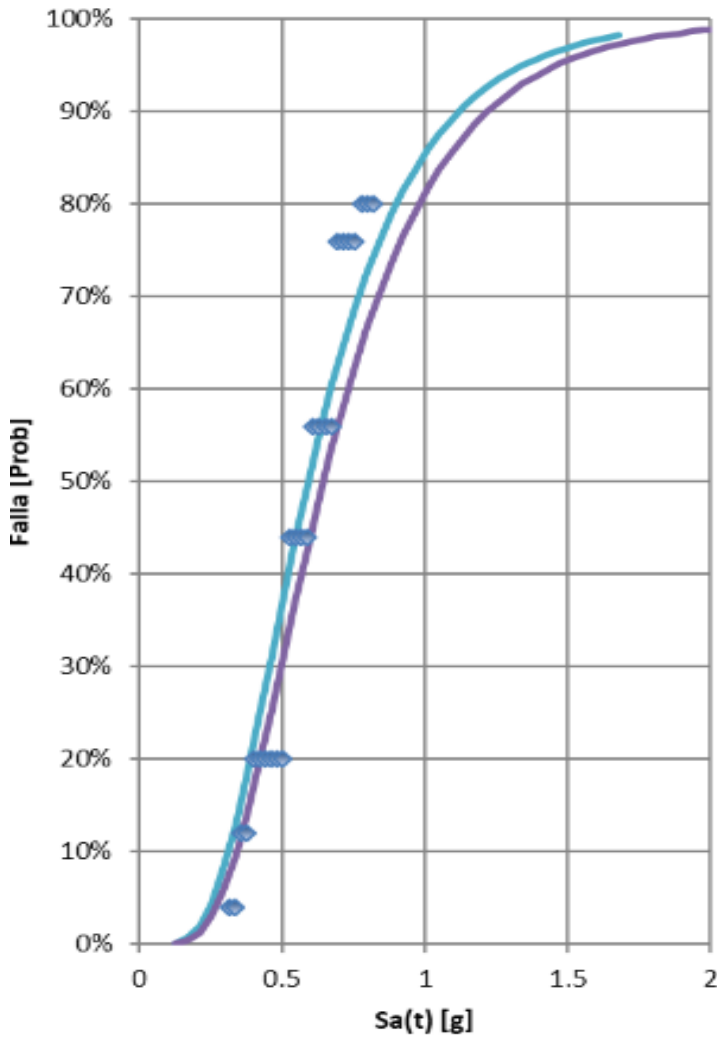
ESTABLISHING SAFETY LEVELS

Element Type Immediate Mid Performance Life Safety

Tipo de Elemento	Ocupación Inmediata (IO)	Punto Intermedio	Seguridad de Vida (LS)
Vigas	1.25	1.6	2.0
Diagonales	1.25	2.0	4.0
Columnas	1.25	1.25	1.25

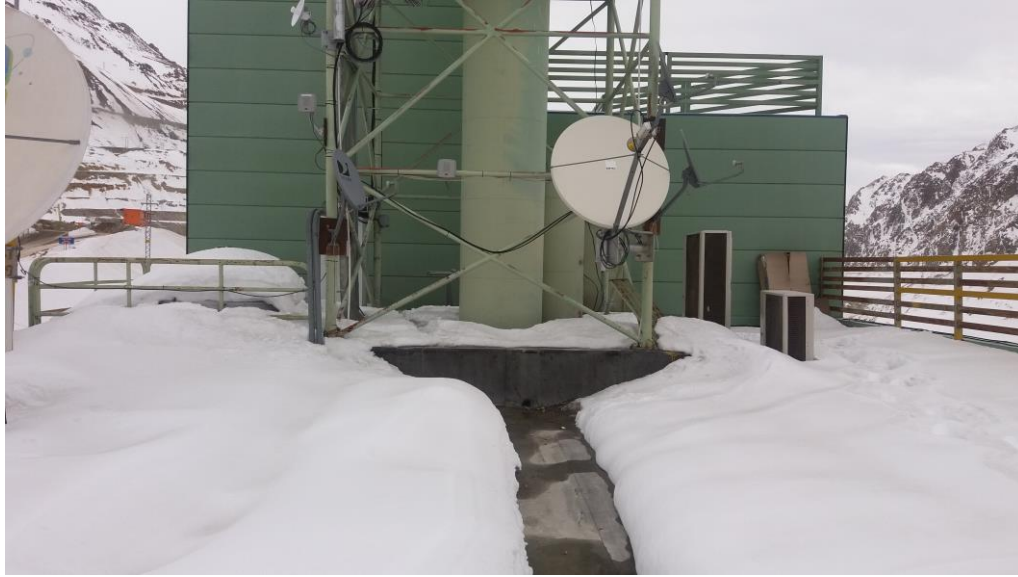
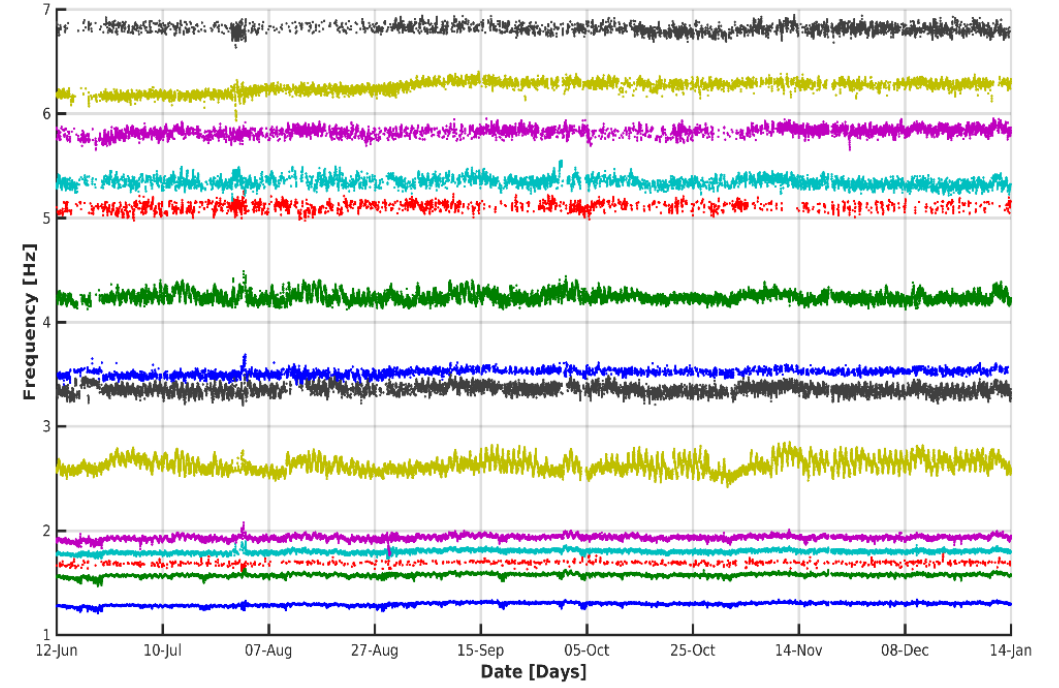
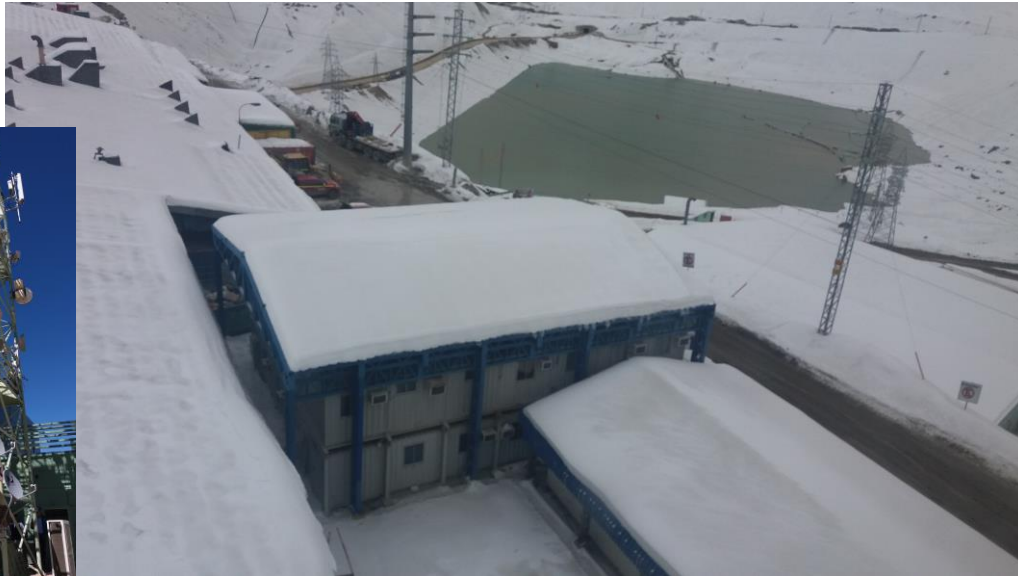
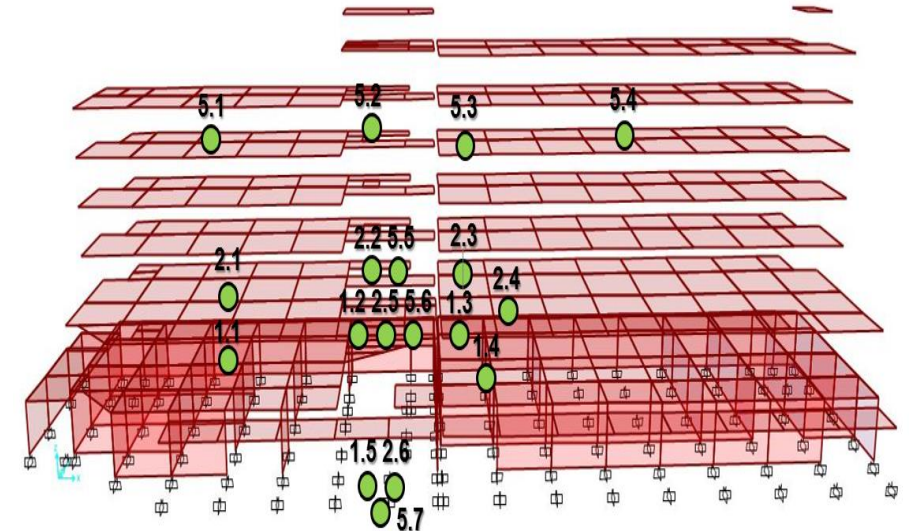
MODEL – UPDATED (?) - VARIATIONS

TRONADURA: 2017.07.04 15.47.19

**SERVICIO RBA-SMA
REPORTE PRELIMINAR 003**

RESULTADO DE LA EVALUACIÓN:

**NO SE SUPERAN LOS LIMITES PREVIAMENTE
DEFINIDOS**

PROYECTO: Efecto de Tronadura
FECHA: 2017-07-04
HORA: 15:47:19
VERSION: 0.1

Elemento	Seccion	FU(COMB0)	FU(COMB1)	Estado	% de Aumento
1	568	XL20x15.1	0.82	0.91		11.01
2	1275	XL20x15.1	0.75	0.78		4.13
3	566	XL20x15.1	0.73	0.75		3.65
4	565	XL20x15.1	0.72	0.74		3.61
5	1318	HN30x128	0.72	0.74		1.86
6	538	Ca150x5	0.7	0.74		4.65
7	1302	HN30x128	0.72	0.74		1.87
8	1326	HN30x128	0.72	0.74		1.88
9	1342	HN30x128	0.72	0.73		1.68
10	2647	IE25x21.1	0.72	0.73		2.34
11	532	Ca150x5	0.69	0.72		5.01
12	1277	XL20x15.1	0.69	0.72		4.07
13	539	Ca150x5	0.7	0.72		2.9
14	2022	Canal15x5.66	0.68	0.71		3.66
15	2672	IE25x21.1	0.68	0.71		4.1
16	1462	HN25x87.4	0.7	0.71		1.83
17	537	Ca150x5	0.69	0.71		2.3
18	2696	IE25x21.1	0.68	0.71		4.37
19	1502	HN25x87.4	0.69	0.7		1.92
20	1283	XL20x15.1	0.67	0.7		4.43
